**DEPARTMENT OF TRANSPORTATION**

Contract #: 04-0120F4Cty: SF/ALA Rte: 80 PM: 13.2/13.9File #: 69.28**WELDING INSPECTION REPORT****Resident Engineer:** Pursell, Gary**Address:** 333 Burma Road**City:** Oakland, CA 94607**Report No:** WIR-000269**Date Inspected:** 01-Jul-2007**Project Name:** SAS Superstructure**OSM Arrival Time:** 900**Prime Contractor:** American Bridge/Fluor Enterprises, a JV**OSM Departure Time:** 1730**Contractor:** Zhenhua Port Machinery Company, Ltd (ZPMC), Changxing Island **Location:** Shanghai, China**CWI Name:** Xu Bing**CWI Present:** Yes No**Inspected CWI report:** Yes No N/A**Rod Oven in Use:** Yes No N/A**Electrode to specification:** Yes No N/A**Weld Procedures Followed:** Yes No N/A**Qualified Welders:** Yes No N/A**Verified Joint Fit-up:** Yes No N/A**Approved Drawings:** Yes No N/A**Approved WPS:** Yes No N/A**Delayed / Cancelled:** Yes No N/A**Bridge No:** 34-0006**Component:** N/A**Summary of Items Observed:**

# WELDING INSPECTION REPORT

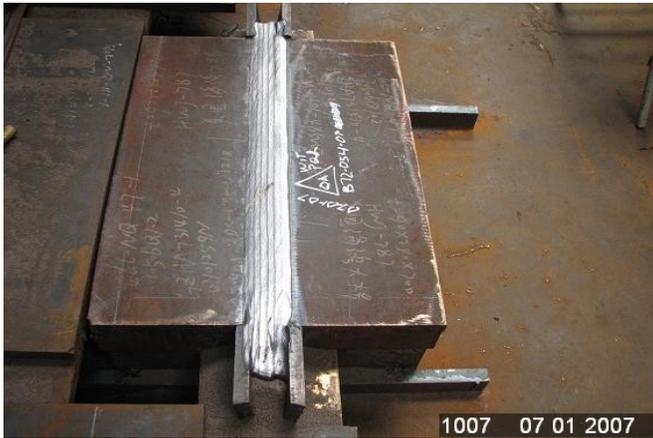
The QA inspector assigned a lot # B72-054-07 on this date to the PQR-HP2007147-1 after performed visual weld inspection to the weld reinforcement.

The photographs below show the PQR HP2007149 in process (right side) and PQR-HP2007147-1 after completion (left side).

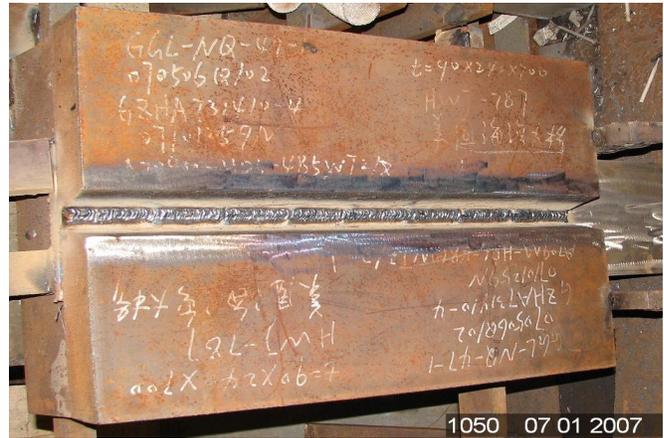
The CALTRANS Quality Assurance (QA) Inspector, Alfredo Acuna was present for the welding qualification testing pertinent for the welding qualification record (PQR) HP2007149 scheduled for this project. ZPMC, welder operator Zhu Hai Ping was observed by the QA Inspector performing welding operations following the preliminary welding procedure specification PWPS-B-T-3213 for the PQR identified as HP2007149. Base metal was designated as A-709 Grade HPS485WT2/Z (Heat # 07101250N). ZPMC followed the Production procedure WPS criteria (AWS 5.13) using the shielded metal arc welding (SMAW) process in the vertical (3G) position with the 4.0 mm diameter designated as E7018-1, brand name THJ506Fe-1. The QA Inspector verified dimensions for the test coupon, amperages, voltages, travel speeds, preheat and heat interpass temperatures. The QA inspector witnessed passes 8 through 16 (layers 7 thru 10). The QA inspectors performed random verifications of the welding parameters for a total of 9 passes. The QA inspectors found that the welding parameters taken by Quality Control (QC) inspector Xu Bing and ZPMC QA inspector Lu Jian Ping appeared to be accurate and in accordance with the contract documents. However, the QA inspector found that ZPMC was not storing low hydrogen electrodes E-7018-1 as per AWS D1.5 and special provisions. The QA inspector had a conversation with the ABF QA inspector Dustin Brungardt. At 1100 hours the QA inspector brought to Mr. Brungardt attention that ZPMC was returning back inside the oven electrodes exposed to the atmosphere and that the electrodes needed to meet the requirements of AWS D1.5 and special provisions. At the 1300 hours ZPMC before re-started welding, the QA inspector questioned Mr. Brungardt how ZPMC was going differentiate the exposed electrodes with other electrodes stored, when the electrodes were on the same tray in the oven. After Mr. Brungardt met with ZPMC representatives. ZPMC and ABF resolution was continuing welding and discard from the project all electrodes after being exposed to the atmosphere from that point forward. The QA inspector had a conversation with Task Leader Robert Cuellar. The QA inspector brought to the attention of Mr. Cuellar that ZPMC returned exposed

electrodes to the oven for welding A-709 Grade HPS485W without separating the exposed electrodes and as corrective action ZPMC was discarding from the project all the electrodes exposed to the atmosphere from that point forward. Mr. Cuellar relayed to the QA inspector that ZPMC was continuing welding at their own risk. ZPMC QC Inspector Xu Bing witnessed the testing and performed visual weld inspections. The PQR HP2007149 was still in process at the end of the shift.
