DEPARTMENT OF TRANSPORTATION

Quality Assurance and Source Inspection

Contract #: 04-0120F4Cty: SF/ALA Rte: 80 PM: 13.2/13.9File #: 69.28**WELDING INSPECTION REPORT****Resident Engineer:** Pursell, Gary**Address:** 333 Burma Road**City:** Oakland, CA 94607**Report No:** WIR-000357**Date Inspected:** 17-Aug-2007**Project Name:** SAS Superstructure**OSM Arrival Time:** 700**Prime Contractor:** American Bridge/Fluor Enterprises, a JV**OSM Departure Time:** 1530**Contractor:** Zhenhua Port Machinery Company, Ltd (ZPMC), Changxing Island **Location:** Shanghai, China**CWI Name:** Huang Wei**CWI Present:** Yes No**Inspected CWI report:** Yes No N/A**Rod Oven in Use:** Yes No N/A**Electrode to specification:** Yes No N/A**Weld Procedures Followed:** Yes No N/A**Qualified Welders:** Yes No N/A**Verified Joint Fit-up:** Yes No N/A**Approved Drawings:** Yes No N/A**Approved WPS:** Yes No N/A**Delayed / Cancelled:** Yes No N/A**Bridge No:** 34-0006**Component:** PQR**Summary of Items Observed:**

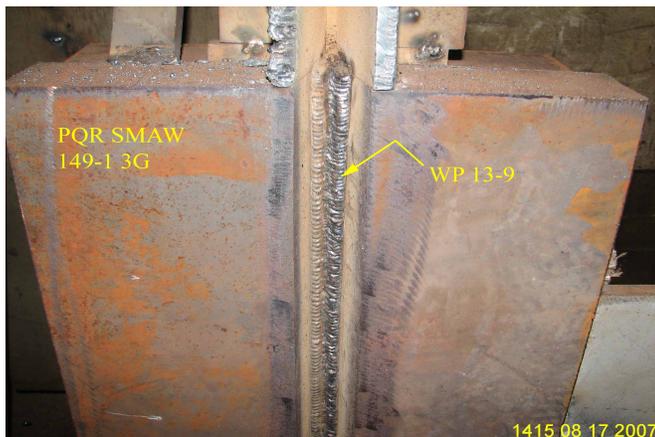
Caltrans Quality Assurance (QA) Inspector Charlie Franco was present at the time requested to randomly observe welding being performed on ZPMC Procedure Qualification Record (PQR) Number HP2007149-1. The welding is being attempted with the shielded metal arc welding (SMAW) process in the 3G or vertical groove position. The PQR weld joint is a single V groove with a 30 degree included groove angle, a 10 millimeter root opening with a 20 millimeter thick by 200 millimeter wide steel backing strip. The QA Inspector observed ZPMC CWI Huang Wei monitoring preheat, welding amperage and welding voltage. Mr. Wei was being assisted by Zhang Daming of the ZPMC Technological Department, who was monitoring travel speed and recording all weld parameters. The QA Inspector also performed random verification of the above weld parameters and documented same. The attached photograph provides additional detail.
