Contract #: 04-0120F4Cty: SF/ALA Rte: 80 PM: 13.2/13.9File #: 69.28**WELDING INSPECTION REPORT****Resident Engineer:** Pursell, Gary**Address:** 333 Burma Road**City:** Oakland, CA 94607**Report No:** WIR-000402**Date Inspected:** 27-Aug-2007**Project Name:** SAS Superstructure**OSM Arrival Time:** 630**Prime Contractor:** American Bridge/Fluor Enterprises, a JV**OSM Departure Time:** 1400**Contractor:** Zhenhua Port Machinery Company, Ltd (ZPMC), Changxing Island **Location:** Shanghai, China**CWI Name:** Ye Yongjun**CWI Present:** Yes No**Inspected CWI report:** Yes No N/A**Rod Oven in Use:** Yes No N/A**Electrode to specification:** Yes No N/A**Weld Procedures Followed:** Yes No N/A**Qualified Welders:** Yes No N/A**Verified Joint Fit-up:** Yes No N/A**Approved Drawings:** Yes No N/A**Approved WPS:** Yes No N/A**Delayed / Cancelled:** Yes No N/A**Bridge No:** 34-0006**Component:** Side Bend Testing / CVN**Summary of Items Observed:**

Side Bend Testing

WELDING INSPECTION REPORT

Charpy Vee Notch Testing

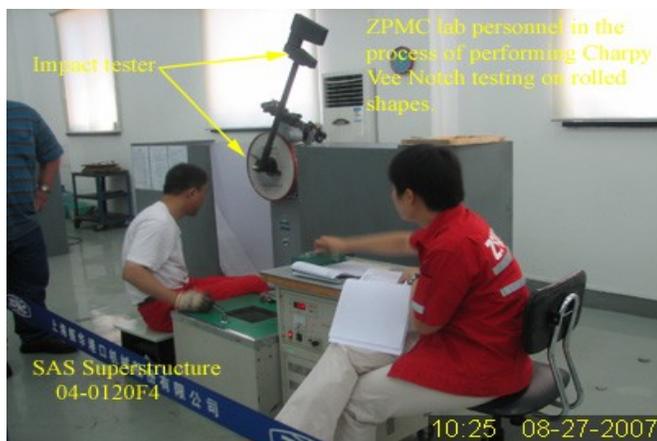
QA Inspector Brannon randomly observed ZPMC impact testing of Charpy Vee Notch Test (CVN) specimens for rolled wide flange beams. Also, observing (CVN) ZPMC Mr. Ye Yongjun and ABF representative Mr. Jeff Evans. Results of testing are as follows:

The tests results identified above have been tested at 4 degrees Celsius and were observed and recorded as having impact energy values stated above. Note: 1- Failing test identified above have an * symbol and will be retested.

The following digital photograph illustrates ZPMC lab personnel in the process of performing Charpy Vee Notch Testing of rolled wide flange beams.
