Contract #: 04-0120F4Cty: SF/ALA Rte: 80 PM: 13.2/13.9File #: 69.28**WELDING INSPECTION REPORT****Resident Engineer:** Pursell, Gary**Address:** 333 Burma Road**City:** Oakland, CA 94607**Report No:** WIR-000405**Date Inspected:** 05-Sep-2007**Project Name:** SAS Superstructure**OSM Arrival Time:** 2330**Prime Contractor:** American Bridge/Fluor Enterprises, a JV**OSM Departure Time:** 800**Contractor:** Zhenhua Port Machinery Company, Ltd (ZPMC), Changxing Island **Location:** Shanghai, China**CWI Name:** Lu Jian Ping & Huang Li**CWI Present:** Yes No**Inspected CWI report:** Yes No N/A**Rod Oven in Use:** Yes No N/A**Electrode to specification:** Yes No N/A**Weld Procedures Followed:** Yes No N/A**Qualified Welders:** Yes No N/A**Verified Joint Fit-up:** Yes No N/A**Approved Drawings:** Yes No N/A**Approved WPS:** Yes No N/A**Delayed / Cancelled:** Yes No N/A**Bridge No:** 34-0006**Component:** Mock-Up**Summary of Items Observed:**

Caltrans Quality Assurance (QA) Inspector, Mike Hasler was present to observe the fitup, welding and related activities associated with the fabricating of Caltrans Mock-up, 77.00 and 114.00, for the San Francisco Oakland Bay Self Anchored Suspension B

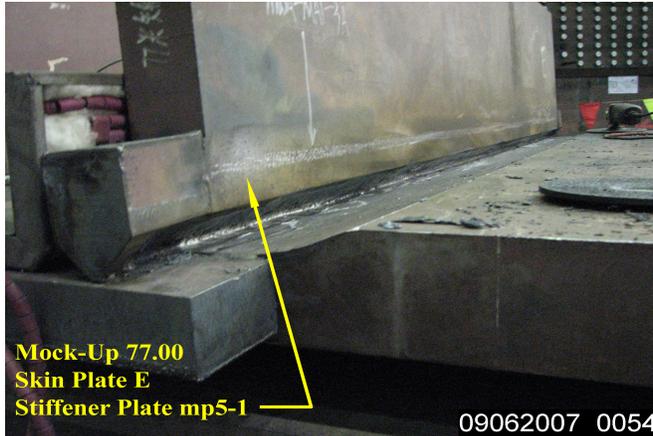
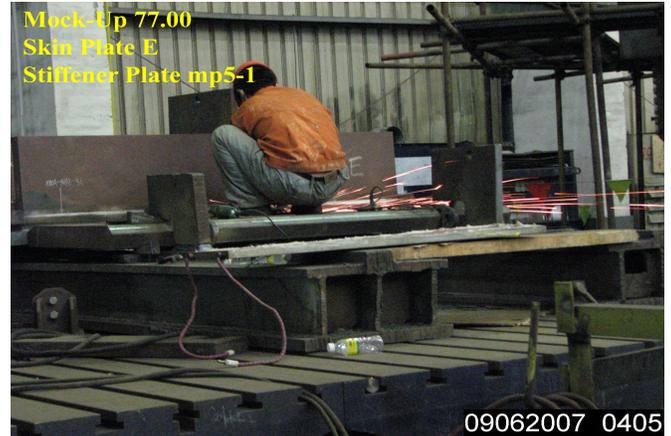
Mock-Up 77.00, skin plate E assembly: Caltrans QA Inspector observed ZPMC shop worker perform air carbon arc backgouge, weld joint preparation. The stiffener plate is identified as mp5-1 to MA1, weld map number MUSA-MA1-3A. ZPMC QA inspector, Mr. Shen Xue Jun reported that the grinding of the weld joint would not be completed during this workshift, but would be turned over to day shift for completion. Following digital picture illustrated weld joint preparation.

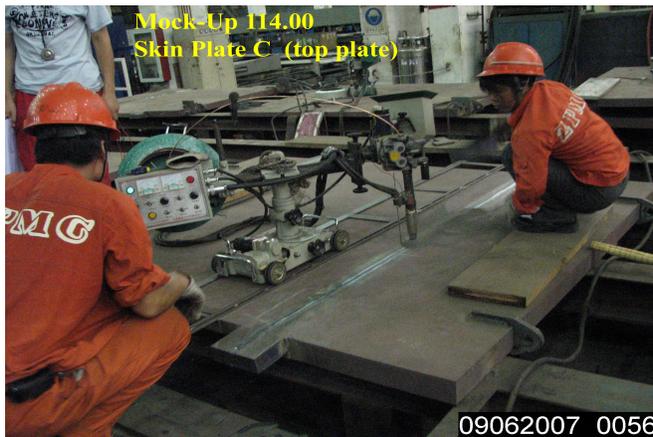
Mock-Up 114.00, Skin Plate C (top plate): Caltrans QA Inspector observed submerged arc welding (SAW) in progress at plate piecemark, mp1019 to MA112, weld number MUSC-MA-112-1, MUSC-MA112-2 and mp1021 to MA112, and weld number MUSC-MA-112-4. The approved welder operator is observed welding a partial joint penetration (PJP) fill/cover pass weld in the flat position. Welder is identified as Mr. Han Chang Hou. The welder is using welding procedure specification WPS-B-T-2321-B-P3-S, Revision 0. Caltrans QA measured current welding parameters at approximately 650 amps, 34.5 volts and travel speed, 630 millimeters per minute (mm/min). Preheat and interpass temperatures were verified during welding activities. Preheat temperature prior to the start of welding measures more than 110 degrees Celsius (230 degree Fahrenheit) but less than 232 degrees Celsius (450 degrees Fahrenheit) during maximum interpass temperature verification. SAW consumables were verified and identified as JW-3, classification EM12K, diameter 4.8 mm (.189 inches) electrode and, JF-B Flux, classification F7A2. Following digital picture illustrates welding in progress at weld number MUSC-MA112-1.
