**DEPARTMENT OF TRANSPORTATION**

Contract #: 04-0120F4Cty: SF/ALA Rte: 80 PM: 13.2/13.9File #: 69.28**WELDING INSPECTION REPORT****Resident Engineer:** Pursell, Gary**Address:** 333 Burma Road**City:** Oakland, CA 94607**Report No:** WIR-000426**Date Inspected:** 24-Aug-2007**Project Name:** SAS Superstructure**OSM Arrival Time:** 630**Prime Contractor:** American Bridge/Fluor Enterprises, a JV**OSM Departure Time:** 1530**Contractor:** Zhenhua Port Machinery Company, Ltd (ZPMC), Changxing Island **Location:** Shanghai, China

# WELDING INSPECTION REPORT

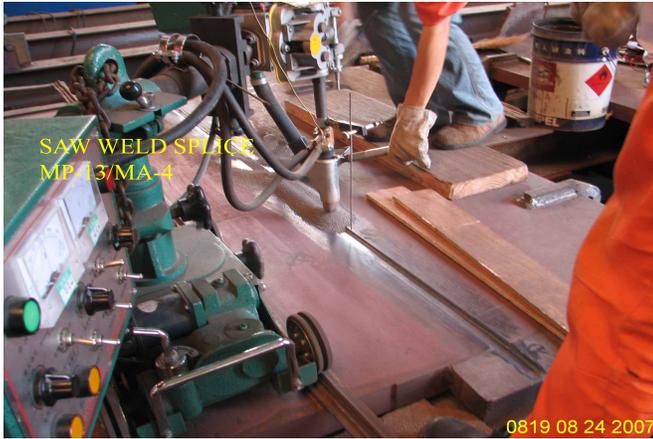
Caltrans Quality Assurance (QA) Inspector Charlie Franco was present at the time requested to randomly observe welding being performed for the Mock Up at elevation 77. The welding is being performed with the submerged arc welding (SAW) process in the 1G or flat groove position. ZPMC welder Xue Yi An was observed welding the splice between skin plates Mp-12 and Ma-4, and ZPMC welder Shen Mei was observed welding the splice between Mp-13 and Ma-4. The QA Inspector observed ZPMC CWI Xa La Feng monitoring preheat, welding amperage, welding voltage and travel speed. The QA Inspector also performed random verification of the above weld parameters at a weld amperage of 685 amps with a corresponding weld voltage of 32 volts and a travel speed of 611.2 millimeters per minute on the cover pass of weld splice Mp-13 to Ma-4. The weld procedure in use was WPS-B-T-2321-B-P3-S. The QA Inspector also observed ZPMC NDT Technician Cai Xin Xin performing magnetic particle examination of the cover pass on the weld splice between skin plates Mp-16 and Ma-5. There appeared to be no indications. The following photograph provides additional detail.
