**DEPARTMENT OF TRANSPORTATION**

Contract #: 04-0120F4Cty: SF/ALA Rte: 80 PM: 13.2/13.9File #: 69.28**WELDING INSPECTION REPORT****Resident Engineer:** Pursell, Gary**Address:** 333 Burma Road**City:** Oakland, CA 94607**Report No:** WIR-000476**Date Inspected:** 22-Aug-2007**Project Name:** SAS Superstructure**OSM Arrival Time:** 545**Prime Contractor:** American Bridge/Fluor Enterprises, a JV**OSM Departure Time:** 1530**Contractor:** Zhenhua Port Machinery Company, Ltd (ZPMC), Changxing Island **Location:** Shanghai, China**CWI Name:** Xu Lefeng**CWI Present:** Yes No**Inspected CWI report:** Yes No N/A**Rod Oven in Use:** Yes No N/A**Electrode to specification:** Yes No N/A**Weld Procedures Followed:** Yes No N/A**Qualified Welders:** Yes No N/A**Verified Joint Fit-up:** Yes No N/A**Approved Drawings:** Yes No N/A**Approved WPS:** Yes No N/A**Delayed / Cancelled:** Yes No N/A**Bridge No:** 34-0006**Component:** Mock-Up Assembly 77M**Summary of Items Observed:**

# WELDING INSPECTION REPORT

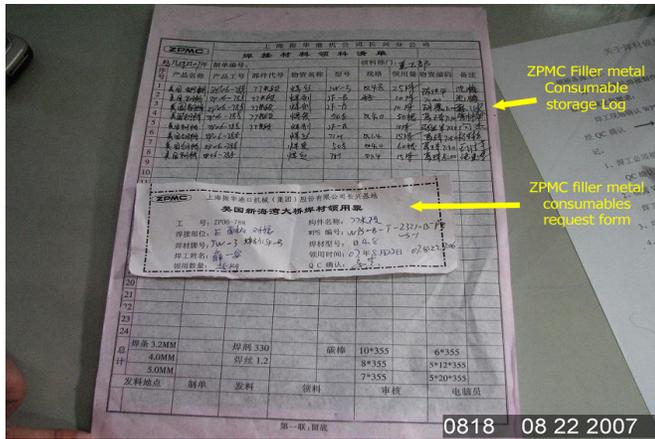
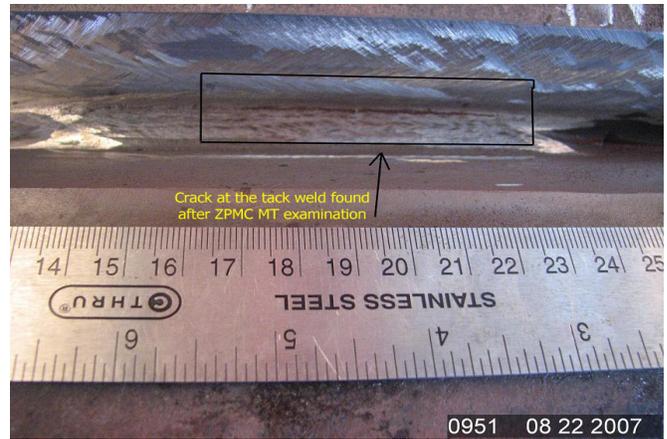
The QA inspector Mike Hasler, ZPMC QA inspector Xu Jun and the QA inspector visited the ZPMC electrode storage areas located at the back of the Tower Mock up fabrication shop. Mr. Xu relayed to the QA inspectors that the ZPMC QC inspector at the welding area fills a welding consumable request form and a ZPMC worker takes the request form to the electrode storage personnel where the welding consumables are provided to the worker. The welding consumables storage personnel log the time, amount, type and purpose of the welding consumables. The digital photograph below shows the ZPMC electrode control forms used on the San Francisco Bay Bridge Project.
