DEPARTMENT OF TRANSPORTATION

Quality Assurance and Source Inspection

Contract #: 04-0120F4Cty: SF/ALA Rte: 80 PM: 13.2/13.9File #: 69.28**WELDING INSPECTION REPORT****Resident Engineer:** Pursell, Gary**Address:** 333 Burma Road**City:** Oakland, CA 94607**Report No:** WIR-000535**Date Inspected:** 26-Sep-2007**Project Name:** SAS Superstructure**OSM Arrival Time:** 630**Prime Contractor:** American Bridge/Fluor Enterprises, a JV**OSM Departure Time:** 1530**Contractor:** Zhenhua Port Machinery Company, Ltd (ZPMC), Changxing Island **Location:** Shanghai, China**CWI Name:** Xu Bing & Gu Xinzhai**CWI Present:** Yes No**Inspected CWI report:** Yes No N/A**Rod Oven in Use:** Yes No N/A**Electrode to specification:** Yes No N/A**Weld Procedures Followed:** Yes No N/A**Qualified Welders:** Yes No N/A**Verified Joint Fit-up:** Yes No N/A**Approved Drawings:** Yes No N/A**Approved WPS:** Yes No N/A**Delayed / Cancelled:** Yes No N/A**Bridge No:** 34-0006**Component:** Mock Up**Summary of Items Observed:**

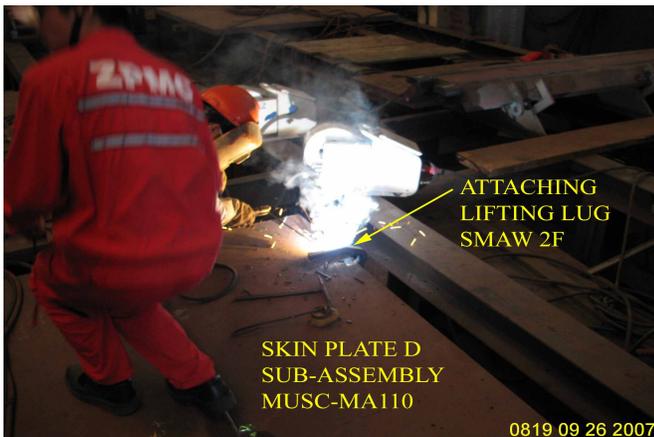
The QA Inspector observed ZPMC qualified welders Gou Dengyun and Chen Ru Yang utilizing the Shielded Metal Arc Welding (SMAW) process, to attach lifting lugs to SA MUSC-MA110 Face D (Skin Plate D). Mr. Guo and Mr. Chen were utilizing ZPMC weld procedure specification WPS-B-P-2112 with 4 millimeter diameter welding rod. The QA Inspector observed ZPMC CWI Xu Bing monitoring weld parameters. The QA Inspector also performed random verification of the weld parameters and documented them as follows: welding amperage 230 amps, welding voltage 23 volts for Mr. Guo and 225 amps, 26 volts for Mr. Chen. Weld parameters appeared to comply with the above approved ZPMC WPS. The following photograph provides additional detail.

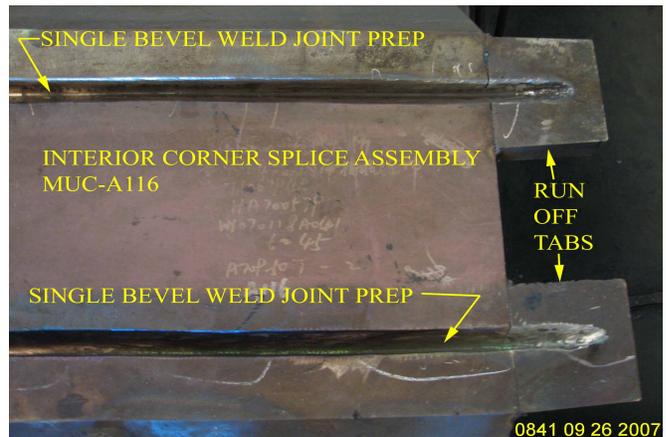
The QA Inspector observed ZPMC welding personnel preparing the bevels for welding on Interior Corner Splice Assembly MUC-A116. The following photograph provides additional detail.
