DEPARTMENT OF TRANSPORTATION

Quality Assurance and Source Inspection

Contract #: 04-0120F4Cty: SF/ALA Rte: 80 PM: 13.2/13.9File #: 1.28**WELDING INSPECTION REPORT****Resident Engineer:** Pursell, Gary**Address:** 333 Burma Road**City:** Oakland, CA 94607**Report No:** WIR-000590**Date Inspected:** 08-Oct-2007**Project Name:** SAS Superstructure**OSM Arrival Time:** 700**Prime Contractor:** American Bridge/Fluor Enterprises, a JV**OSM Departure Time:** 1530**Contractor:** American Bridge/Fluor Enterprises, a JV**Location:** Benicia, CA**CWI Name:** Michael Johnson**CWI Present:** Yes No**Inspected CWI report:** Yes No N/A**Rod Oven in Use:** Yes No N/A**Electrode to specification:** Yes No N/A**Weld Procedures Followed:** Yes No N/A**Qualified Welders:** Yes No N/A**Verified Joint Fit-up:** Yes No N/A**Approved Drawings:** Yes No N/A**Approved WPS:** Yes No N/A**Delayed / Cancelled:** Yes No N/A**Bridge No:** 34-0006**Component:** Procedure Qualification Record (PQR) Test**Summary of Items Observed:**

WELDING INSPECTION REPORT

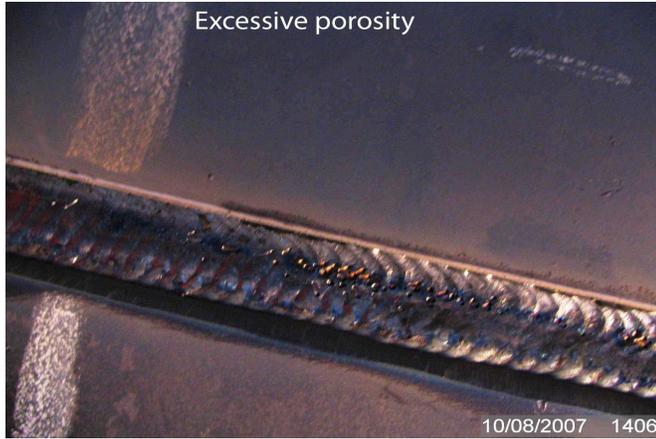
In the beginning of the shift the QA Inspector observed the welding operators set up and weld on (2) non-PQR test plates. Later in the shift the QA Inspector observed the welding operators deposit (3) weld passes onto PQR test plate known as ABF-PQR-015-1 in the 4G position. The welders used 1/16 inch diameter (1.6mm) ESAB 70 Ultra-Plus E70T-1 (FCAW-G) welding wire and 90% Argon/ 10% Carbon Dioxide gas. The welding operators utilized a Bug-O welding device to deposit these welds. The QA Inspector observed that the welders were depositing welds that contained excessive porosity and were having mechanical difficulties with the Bug-O mechanical device. The QA Inspector observed that the welders removed the porosity (see photo below for additional information) by grinding before depositing the next weld pass. ABF informed the QA Inspector that it was decided to ship the Bug-O unit out for repair. ABF informed the QA Inspector that they would be using an ESAB Rail-Track for the remainder of this PQR test. For specific welding parameters recorded during this PQR test see Caltrans Welding Witness Report, TL-6032 generated upon the completion of this PQR test.
