DEPARTMENT OF TRANSPORTATION

Quality Assurance and Source Inspection

Contract #: 04-0120F4Cty: SF/ALA Rte: 80 PM: 13.2/13.9File #: 69.28**WELDING INSPECTION REPORT****Resident Engineer:** Pursell, Gary**Address:** 333 Burma Road**City:** Oakland, CA 94607**Report No:** WIR-000629**Date Inspected:** 12-Oct-2007**Project Name:** SAS Superstructure**OSM Arrival Time:** 630**Prime Contractor:** American Bridge/Fluor Enterprises, a JV**OSM Departure Time:** 1530**Contractor:** Zhenhua Port Machinery Company, Ltd (ZPMC), Changxing Island **Location:** Changxing Island**CWI Name:** Lujian Bing**CWI Present:** Yes No**Inspected CWI report:** Yes No N/A**Rod Oven in Use:** Yes No N/A**Electrode to specification:** Yes No N/A**Weld Procedures Followed:** Yes No N/A**Qualified Welders:** Yes No N/A**Verified Joint Fit-up:** Yes No N/A**Approved Drawings:** Yes No N/A**Approved WPS:** Yes No N/A**Delayed / Cancelled:** Yes No N/A**Bridge No:** 34-0006**Component:** 89 Mock-up**Summary of Items Observed:**

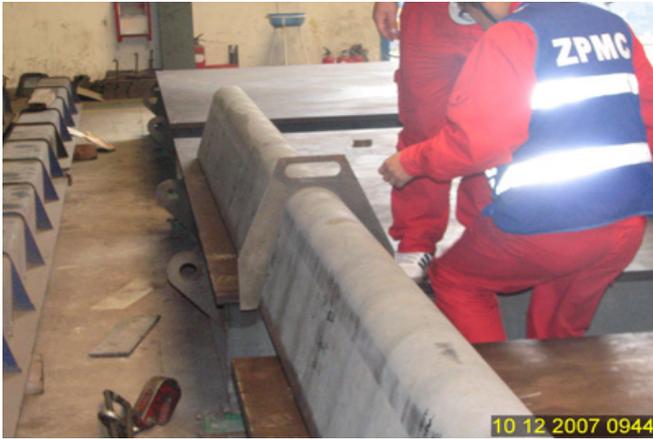
Caltrans QA Inspector observed ZPMC QC technicians performing dimensional measurements of 10 meter closed ribs. ZPMC QC personnel were noted taking measurements of longitudinal straightness and profile measurements with a template as seen in the digital picture below on closed rib U21.

Caltrans QA Inspector observed that the welding and dimensional testing above appeared to be in general conformance with AWS D1.5 2002 requirements.
