Quality Assurance and Source Inspection

Contract #: 04-0120F4Cty: SF/ALA Rte: 80 PM: 13.2/13.9File #: 69.28**WELDING INSPECTION REPORT****Resident Engineer:** Pursell, Gary**Address:** 333 Burma Road**City:** Oakland, CA 94607**Report No:** WIR-000657**Date Inspected:** 15-Oct-2007**Project Name:** SAS Superstructure**OSM Arrival Time:** 1330**Prime Contractor:** American Bridge/Fluor Enterprises, a JV**OSM Departure Time:** 1900**Contractor:** Zhenhua Port Machinery Company, Ltd (ZPMC), Changxing Island **Location:** Shanghai, China**CWI Name:** Fu Yu Hong**CWI Present:** Yes No**Inspected CWI report:** Yes No N/A**Rod Oven in Use:** Yes No N/A**Electrode to specification:** Yes No N/A**Weld Procedures Followed:** Yes No N/A**Qualified Welders:** Yes No N/A**Verified Joint Fit-up:** Yes No N/A**Approved Drawings:** Yes No N/A**Approved WPS:** Yes No N/A**Delayed / Cancelled:** Yes No N/A**Bridge No:** 34-0006**Component:** U-Rib Trial Assembly**Summary of Items Observed:**

WELDING INSPECTION REPORT

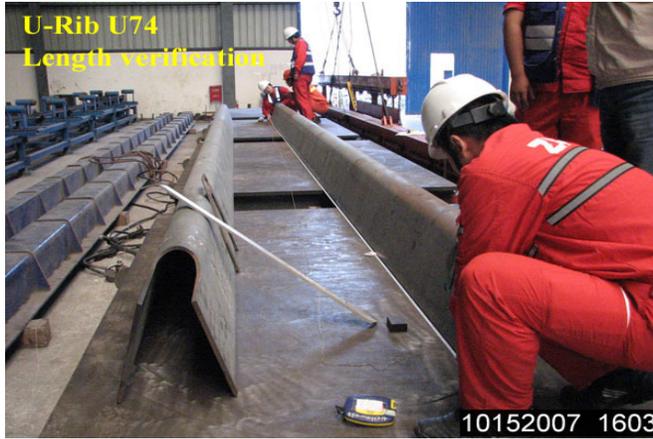
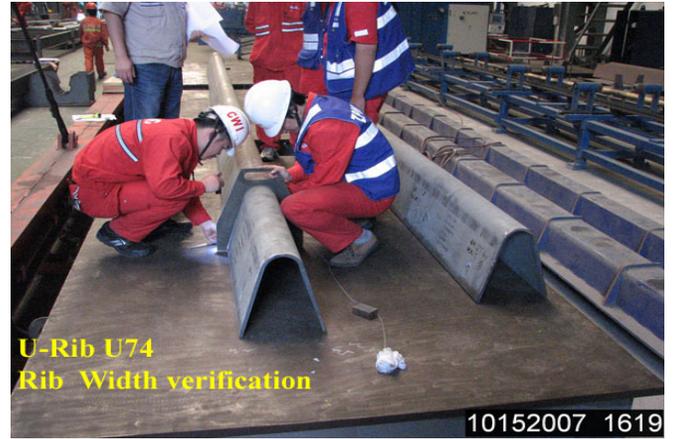
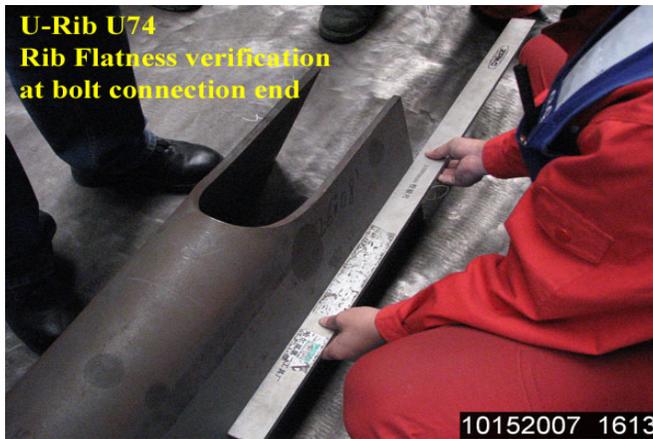
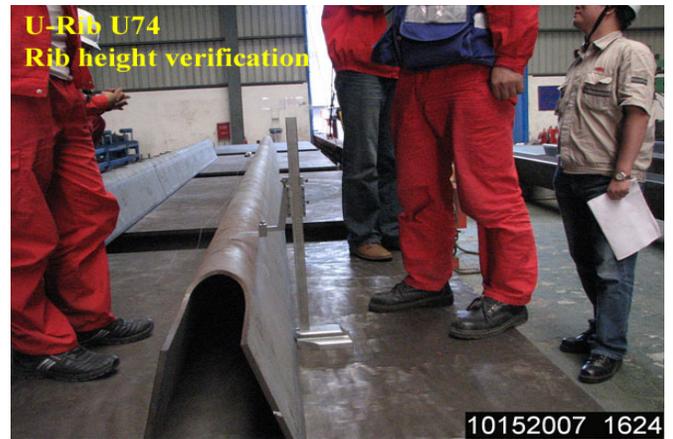
Caltrans QA Inspector performed dimensional verification of the U-Rib Trial Assembly, identified as U74. American Bridge/Fluor (ABF) representative, Mr. Peter Ferguson informed Caltrans QA Inspector that the U74 rib trial assembly dimensional call-out, per ZPMC verification record 787-QCR-204 has been verified by ABF and no discrepancies were observed. Caltrans QA Inspector verified dimensional requirements for rib length, height, warpage, straightness, flatness and width. The required dimensions appeared to be in compliant with the dimensional tolerance requirements. Following digital pictures illustrates dimensional inspection performed.
