**DEPARTMENT OF TRANSPORTATION**

Contract #: 04-0120F4Cty: SF/ALA Rte: 80 PM: 13.2/13.9File #: 69.28**WELDING INSPECTION REPORT****Resident Engineer:** Pursell, Gary**Address:** 333 Burma Road**City:** Oakland, CA 94607**Report No:** WIR-000659**Date Inspected:** 17-Oct-2007**Project Name:** SAS Superstructure**OSM Arrival Time:** 630**Prime Contractor:** American Bridge/Fluor Enterprises, a JV**OSM Departure Time:** 1530**Contractor:** Zhenhua Port Machinery Company, Ltd (ZPMC), Changxing Island **Location:** Changxing Island

# WELDING INSPECTION REPORT

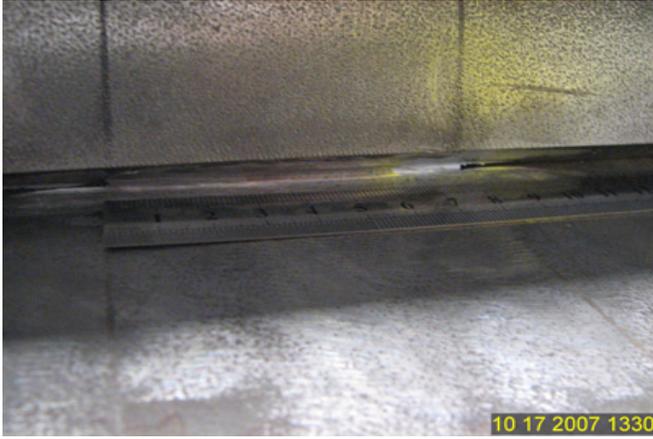
Caltrans QA Inspector witnessed ZPMC personnel performing dimensional measurements of tack weld length and spacing as well as fit-up gap of Orthotropic Box Girder (OBG). Dimensions were marked at adjacent locations on closed ribs. Measurements of the tack weld length appear to have been taken from the end to end including transition areas. The following pictures below shows the profile of tack weld after blending.

Comparison of measurements taken from ZPMC and Caltrans of the tack weld length appeared to be similar with minimal deviation. Tack welds were blended and transitioned for root pass welding. A total of 17 tack welds were noted on each weld.
