Contract #: 04-0120F4Cty: SF/ALA Rte: 80 PM: 13.2/13.9File #: 69.28**WELDING INSPECTION REPORT****Resident Engineer:** Pursell, Gary**Address:** 333 Burma Road**City:** Oakland, CA 94607**Report No:** WIR-000668**Date Inspected:** 17-Oct-2007**Project Name:** SAS Superstructure**OSM Arrival Time:** 1430**Prime Contractor:** American Bridge/Fluor Enterprises, a JV**OSM Departure Time:** 2300**Contractor:** Zhenhua Port Machinery Company, Ltd (ZPMC), Changxing Island **Location:** Shanghai, China

OBG-CLOSED RIB TRIALS

WELDING INSPECTION REPORT

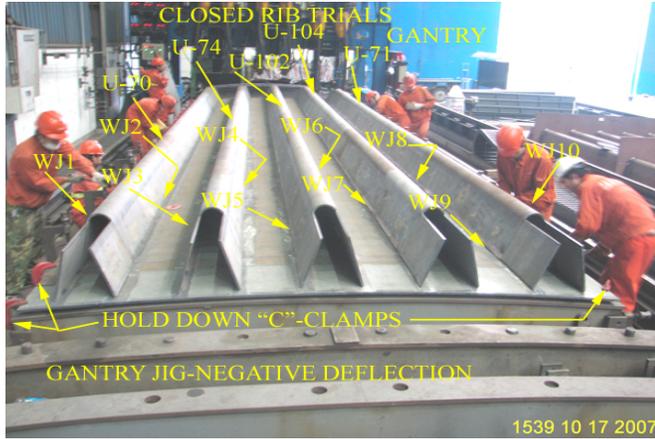
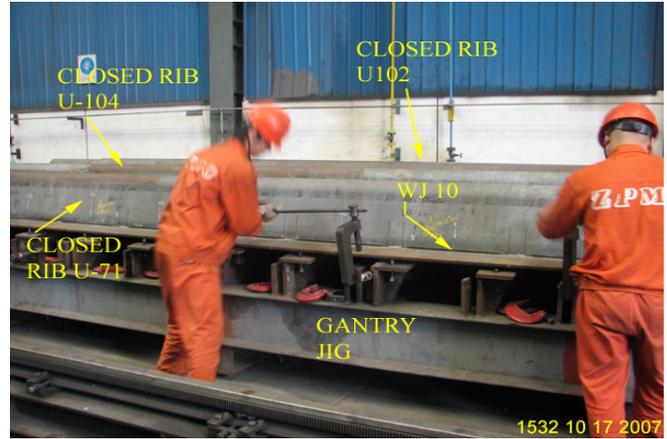
The Caltrans Quality Assurance (QA) Inspector Charlie Franco was present at the time requested to randomly observe welding and associated operations being performed for the OBG Closed Rib Trials. The QA Inspector observed that the Closed Rib Trial Assembly was in the process of being clamped down onto the jig for the Gas Metal Arc Welding (GMAW) and Submerged Arc Welding (SAW) gantry. The gantry jig allows for the Closed Rib Trial Assembly to be clamped down and placed in a negative deflection for welding. The QA Inspector was informed by Pete Ferguson of ABF, that ZPMC had jumped the gun, removed the Closed Rib Trial Assembly from the welding table and placed it on the gantry jig. Mr. Ferguson also informed the QA Inspector, that the Closed Rib Trial Assembly would be unclamped from the gantry jig and returned to the welding table, where required dimensions could be rechecked by ZPMC and then verified by the QA Inspector. The QA Inspector observed the CRTA being unclamped, removed from the gantry jig and returned to the welding table. Mr. Ferguson informed the QA Inspector that after ZPMC had rechecked the dimensions, that ZPMC would inform the QA Inspector so that the QA Inspector could perform his verification of the tack welds and gap between the ribs and the CRTA bottom plate. ZPMC was not able to verify the original dimensions and the QA Inspector and therefore, the QA Inspector was not able to verify any dimensions. The attached photographs provide additional details.

Arbin of Bureau Veritas and Eric Hu of ZPMC, informed the QA Inspector that several dimensions had changed due to the moving of the Closed Rib Trial Assembly and the clamping down of it onto the gantry jig, and that the Closed Rib Trial Assembly was not fully released to the QA Inspector.
