**DEPARTMENT OF TRANSPORTATION**

Contract #: 04-0120F4Cty: SF/ALA Rte: 80 PM: 13.2/13.9File #: 69.28**WELDING INSPECTION REPORT****Resident Engineer:** Pursell, Gary**Address:** 333 Burma Road**City:** Oakland, CA 94607**Report No:** WIR-000719**Date Inspected:** 16-Oct-2007**Project Name:** SAS Superstructure**OSM Arrival Time:** 630**Prime Contractor:** American Bridge/Fluor Enterprises, a JV**OSM Departure Time:** 1530**Contractor:** Zhenhua Port Machinery Company, Ltd (ZPMC), Changxing Island **Location:** Changxing Island**CWI Name:** Fu Guo Gau**CWI Present:** Yes No**Inspected CWI report:** Yes No N/A**Rod Oven in Use:** Yes No N/A**Electrode to specification:** Yes No N/A**Weld Procedures Followed:** Yes No N/A**Qualified Welders:** Yes No N/A**Verified Joint Fit-up:** Yes No N/A**Approved Drawings:** Yes No N/A**Approved WPS:** Yes No N/A**Delayed / Cancelled:** Yes No N/A**Bridge No:** 34-0006**Component:** OBG Closed Rib Trail**Summary of Items Observed:**

Caltrans Quality Assurance (QA) Inspector, Larry Viars was present to observe the dimensional testing and welding of Orthotropic Box Girder (OBG) Mock-up closed rib trial, for the San Francisco Oakland Bay Self Ancho

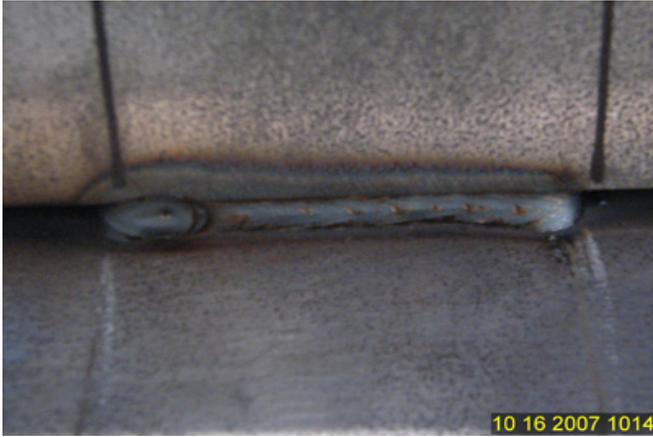
Caltrans QA observed ZPMC welder Mr. Yang Yong Zeng performing Gas Metal Arc Welding (GMAW) of closed rib tack welding. ZPMC QA Fu Yuhong stated, the Welding Procedure Specification used for the tack welding was WPS-B-T-2342-U2 (u-ribs). Caltrans QA inspectors Viars and QA Inspector Alfredo Acuna observed that the ZPMC Quality Control (QC) measurement of travel speed time and Caltrans QA recorded time differed by three seconds. American Bridge Flour (ABF) QC representative Mr. Craig Knops stated that the welding time at the start of the tack weld and at the end did not factor into the welding time when starting the puddle or terminating the tack weld. The following picture shows the tack weld profile.

measurements of closed rib to plate fit-up. Welding and fit-up appeared to be in conformance with the Special Revisions and AWS D1.5 requirements at the time of observation.
