**DEPARTMENT OF TRANSPORTATION**

Contract #: 04-0120F4Cty: SF/ALA Rte: 80 PM: 13.2/13.9File #: 69.28**WELDING INSPECTION REPORT****Resident Engineer:** Pursell, Gary**Address:** 333 Burma Road**City:** Oakland, CA 94607**Report No:** WIR-000743**Date Inspected:** 29-Oct-2007**Project Name:** SAS Superstructure**OSM Arrival Time:** 630**Prime Contractor:** American Bridge/Fluor Enterprises, a JV**OSM Departure Time:** 1500**Contractor:** Zhenhua Port Machinery Company, Ltd (ZPMC), Changxing Island **Location:** Shanghai, China

Caltrans Quality Assurance (QA) Inspector, Mike Hasler was present to observe the fit up, welding and related activities associated with the fabricating of Caltrans Mock-up, 77M, 89M, 114M and U-Rib Trial Assembly, for the San Francisco Oakland Bay Self Anchored Suspension Bridge, at Zhenhua Port Machinery Company (ZPMC) facility on Changxing Island.

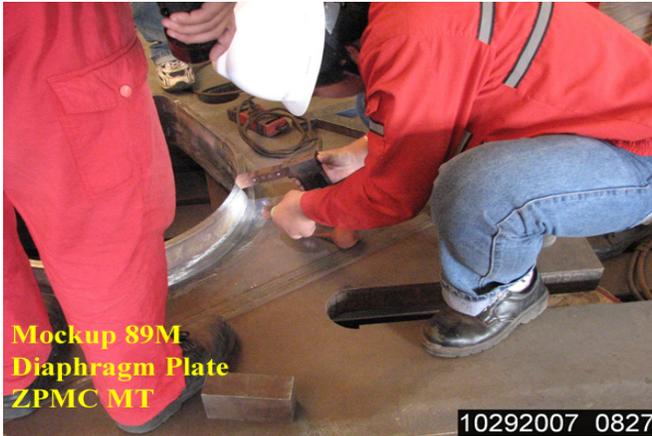
Mock-Up 89M, SA13 (p1235) Diaphragm Plate, Assess Opening Ring: Caltrans QA Inspector witnessed ZPMC Quality Control inspector, Mr. Cai Xin Xin perform magnetic particle test (MT) and Visual Test (VT) inspection at partial joint penetration (PJP), tee-joint weld cover pass, weld 10A and 10B. ZPMC MT coverage appeared to be 100 percent of the weld, The location is identified access opening ring to diaphragm plate p1235. The MT appeared to be in compliance with the project specification and found to be in compliance by QC.

Caltrans QA Inspector performed MT and VT inspection of the weld 10 A and 10B cover pass weld. See Caltrans Magnetic Particle Test Report, TL6028, generated on this date for additional information. Following digital picture illustrates ZPMC MT inspection.

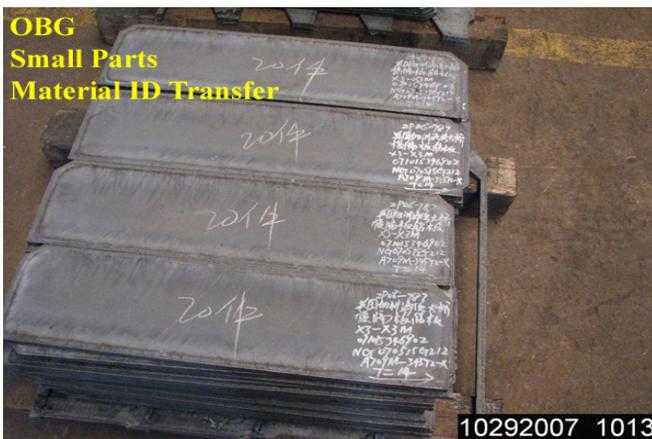
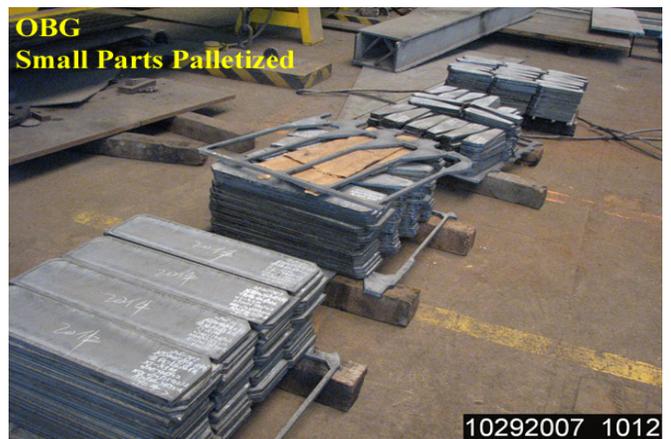
Orthotropic Bridge Girder (OBG): Caltrans QA Inspector observed ZPMC practice welding on the u-rib trial assembly. It appeared that ZPMC was still making welding equipment adjustments at Shop #1. Caltrans QA Inspector observed ZPMC material identification transfer markings for heat number, batch number, material thickness, material type and grade. The small parts were flame cut at the burn table in the Mockup Shop, building #2. These parts were stacked on pallets and identified as X3-X3N, X3-X3L, X3-X3M, and X3-X3K. Following digital pictures illustrates transfer of the material identification and palletized parts.
