DEPARTMENT OF TRANSPORTATION

Contract #: 04-0120F4Cty: SF/ALA Rte: 80 PM: 13.2/13.9File #: 69.28**WELDING INSPECTION REPORT****Resident Engineer:** Pursell, Gary**Address:** 333 Burma Road**City:** Oakland, CA 94607**Report No:** WIR-000745**Date Inspected:** 25-Oct-2007**Project Name:** SAS Superstructure**OSM Arrival Time:** 630**Prime Contractor:** American Bridge/Fluor Enterprises, a JV**OSM Departure Time:** 1500**Contractor:** Zhenhua Port Machinery Company, Ltd (ZPMC), Changxing Island **Location:** Shanghai, China**CWI Name:** Sha Zhi & Huang Li**CWI Present:** Yes No**Inspected CWI report:** Yes No N/A**Rod Oven in Use:** Yes No N/A**Electrode to specification:** Yes No N/A**Weld Procedures Followed:** Yes No N/A**Qualified Welders:** Yes No N/A**Verified Joint Fit-up:** Yes No N/A**Approved Drawings:** Yes No N/A**Approved WPS:** Yes No N/A**Delayed / Cancelled:** Yes No N/A**Bridge No:** 34-0006**Component:** Caltrans Mockup**Summary of Items Observed:**

Caltrans Quality Assurance (QA) Inspector, Mike Hasler was present to observe the fit up, welding and related activities associated with the fabricating of Caltrans Mock-up, 77M, 89M, 114M and U-Rib Trial Assembly, for

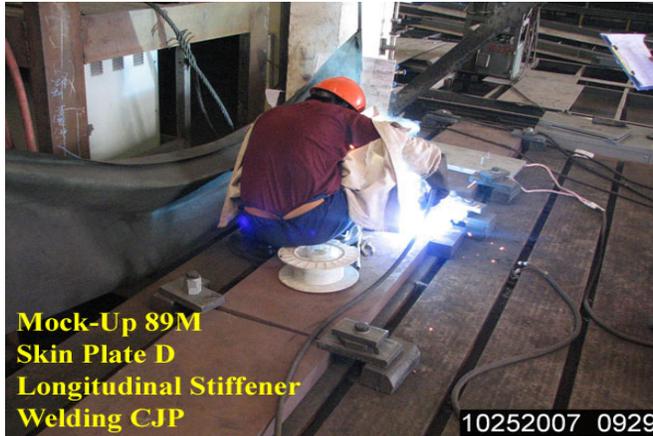
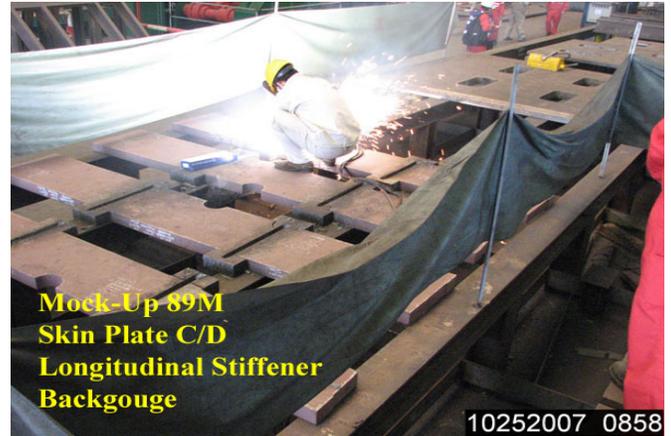
Item	Description	WBS	Dwg No.	Status
1	Skin Plate C/D	NA	NA	Work in Progress

Mock-Up 89M, Skin Plate C/D, Longitudinal Stiffener Plates: Caltrans QA Inspector observed shop worker performing air carbon arc backgouging at complete joint penetration (CJP) weld joint, joining longitudinal stiffeners, where the root pass welds have been completed on the opposite side. Caltrans QA Inspector observed flux cored arc welding (FCAW), splice plate root pass weld, joining piecemark mp537A-1 to mp537B-1 stiffener plates, in the flat position. The welder is identified as Mr. Lei Leihao, welder stamp 053619. The welder is using welding procedure specification WPS-B-T-2231-B-U3-F. Caltrans QA observed ZPMC Quality Control inspector, Mr. Sha Zhi and Mr. Huang Li, monitoring welding activities at the workstation. Caltrans QA Inspector measured current welding parameters at approximately 320 amps, 31 volts and 330 millimeters per minute (mm/min) travel speed. Preheat and interpass temperatures were verified during welding activities. The preheat temperature prior to the start of welding measures more than 110 Celsius (230 degree Fahrenheit) but less than 232 Celsius (450 degrees Fahrenheit) during maximum interpass temperature verification. FCAW consumable is verified and identified as Supercored 71H, classification E71T-1, diameter 1.4 mm (.055 inches). Following digital pictures illustrates air carbon arc gouging and welding in progress

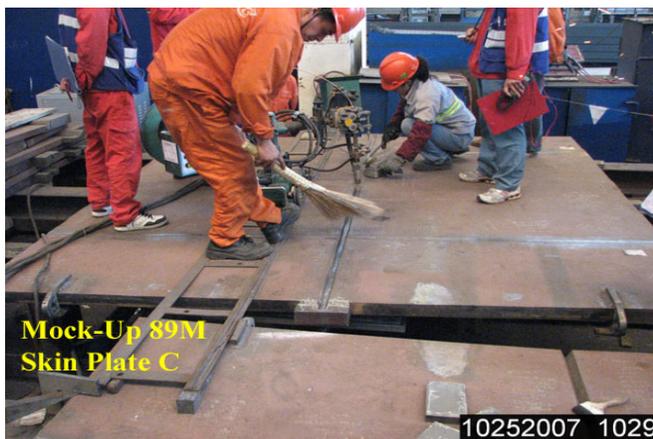
2 Skin Plate C NA NA Welding in Progress

Mock-Up 89M, Skin Plate C: Caltrans QA Inspector observed submerged arc welding (SAW) in progress at complete joint penetration plate splice weld, identified as weld number 25. The welder operator is identified as Mr. Han Changhou, welder stamp 059464, welding fill pass weld in the flat position. The welder is using welding procedure specification, WPS-B-T-2221-B-U3c-S, Revision 0. Caltrans QA Inspector measured current welding parameters at approximately 630 amps, 32.0 volts and travel speed, 580 millimeters per minute (mm/min). Preheat and interpass temperatures were verified during welding activities. Preheat temperature prior to the start of welding measures more than 110 degrees Celsius (230 degree Fahrenheit) but less than 232 degrees Celsius (450 degrees Fahrenheit) during maximum interpass temperature verification. SAW consumables were verified and identified as JW-3, classification EM12K, diameter 4.8 mm (.189 inches) electrode and, JF-B Flux, classification F7A2. Following digital picture illustrates welding in progress.

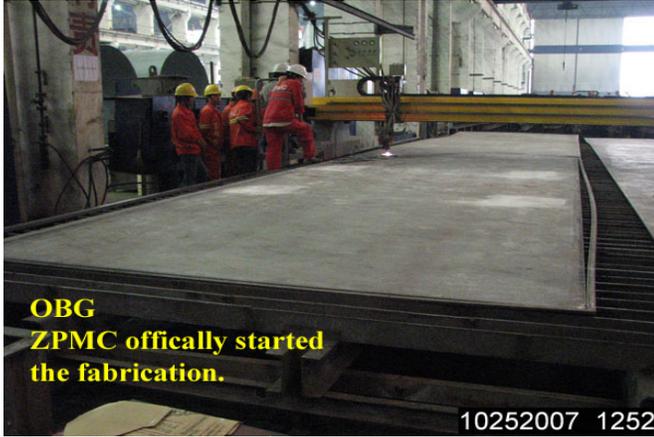
ZPMC informed Caltrans QA inspector that at 10:00 hours, ZPMC is going to officially start fabrication on the Caltrans Project and would be starting with oxy-fuel flame, cutting bottom (X14-X14A) and, side plates for the orthotropic bridge girder. Following digital picture illustrates work in progress.
