Contract #: 04-0120F4Cty: SF/ALA Rte: 80 PM: 13.2/13.9File #: 69.28**WELDING INSPECTION REPORT****Resident Engineer:** Pursell, Gary**Address:** 333 Burma Road**City:** Oakland, CA 94607**Report No:** WIR-000750**Date Inspected:** 31-Oct-2007**Project Name:** SAS Superstructure**OSM Arrival Time:** 630**Prime Contractor:** American Bridge/Fluor Enterprises, a JV**OSM Departure Time:** 1530**Contractor:** Zhenhua Port Machinery Company, Ltd (ZPMC), Changxing Island **Location:** Changxing Island**CWI Name:** Art Peterson**CWI Present:** Yes No**Inspected CWI report:** Yes No N/A**Rod Oven in Use:** Yes No N/A**Electrode to specification:** Yes No N/A**Weld Procedures Followed:** Yes No N/A**Qualified Welders:** Yes No N/A**Verified Joint Fit-up:** Yes No N/A**Approved Drawings:** Yes No N/A**Approved WPS:** Yes No N/A**Delayed / Cancelled:** Yes No N/A**Bridge No:** 34-0006**Component:** OBG Closed Rib Trail**Summary of Items Observed:**

Caltrans Quality Assurance (QA) Inspector, Larry Viars was present to observe the dimensional testing of Orthotropic Box Girder (OBG) Mock-up closed rib trial, for the San Francisco Oakland Bay Self Anchored Suspension Bridge, at Zhenhua Port Machi

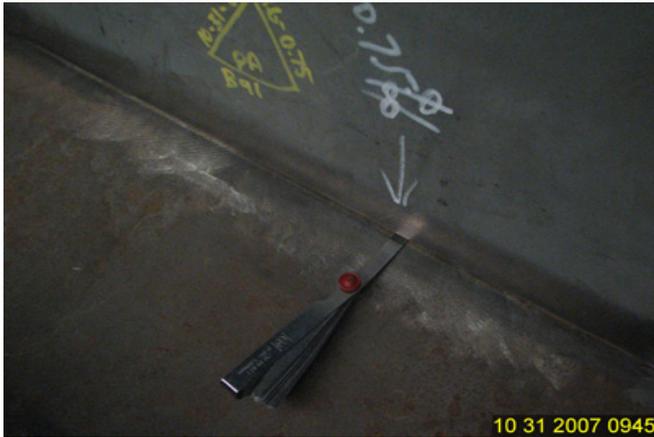
Caltrans QA Inspector Viars performed random measurements of Closed Rib weld Trial rib to deck plate root gap. The maximum gap noted was 0.75 mm located on closed rib # U01, weld # 4. A summary of U-Rib gap measurements are as follows, U-Rib 73 - 3 locations at or over 0.5 mm with a maximum of 0.65 mm, U-Rib 01 - 5 locations at or over 0.5 mm with a maximum of 0.75 mm, U-Rib 75 - 2 locations at or over 0.5 mm with a maximum of 0.75 mm, U-Rib 02 - 3 locations at or over 0.5 mm with a maximum of 0.6 mm and U-Rib 05 - 1 location over 0.5 mm which measured 0.68 mm. Measurements were taken prior to camber. The following picture shows the filler gauge 0.75 mm inserted into U-Rib # 01 on weld # 4 between tacks 16 and 17.

Caltrans QA Inspector Viars performed random dimensional measurements of closed rib to plate fit-up, tack weld length and spacing.
