Contract #: 04-0120F4Cty: SF/ALA Rte: 80 PM: 13.2/13.9File #: 69.28**WELDING INSPECTION REPORT****Resident Engineer:** Pursell, Gary**Address:** 333 Burma Road**City:** Oakland, CA 94607**Report No:** WIR-000756**Date Inspected:** 02-Nov-2007**Project Name:** SAS Superstructure**OSM Arrival Time:** 630**Prime Contractor:** American Bridge/Fluor Enterprises, a JV**OSM Departure Time:** 1530**Contractor:** Zhenhua Port Machinery Company, Ltd (ZPMC), Changxing Island **Location:** Changxing Island**CWI Name:** Arthur Peterson**CWI Present:** Yes No**Inspected CWI report:** Yes No N/A**Rod Oven in Use:** Yes No N/A**Electrode to specification:** Yes No N/A**Weld Procedures Followed:** Yes No N/A**Qualified Welders:** Yes No N/A**Verified Joint Fit-up:** Yes No N/A**Approved Drawings:** Yes No N/A**Approved WPS:** Yes No N/A**Delayed / Cancelled:** Yes No N/A**Bridge No:** 34-0006**Component:** OBG Closed Rib Trial**Summary of Items Observed:**

Caltrans Quality Assurance (QA) Inspector, Larry Viars was present to perform welding inspection of Orthotropic Box Girder (OBG) Mock-up closed rib trial, for the San Francisco Oakland Bay Self Anchored Suspension Bridge, at Zhenhua Port Machine

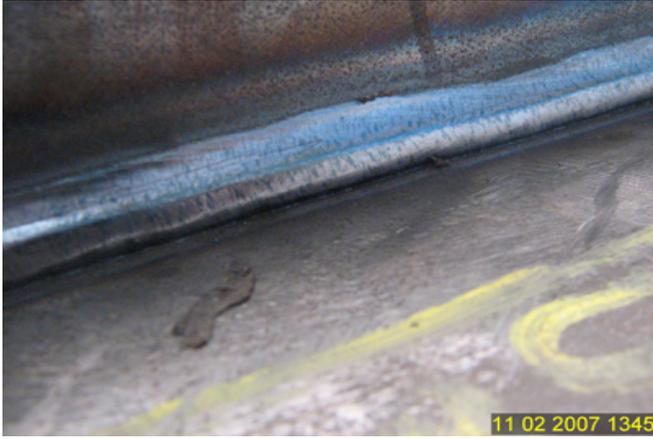
Caltrans QA Inspector Viars observed areas of complete joint penetration at the ends of the ribs. These areas were uniform and appeared to have minimal inside penetration. The visual observations on the inside of the rib was limited due accessibility.

Caltrans QA Inspector Viars performed random visual observations of the closed rib weld trial cover pass on welds # 6 thru # 10. Welding did not appear to meet AWS D1.5 requirements.
