DEPARTMENT OF TRANSPORTATION

Quality Assurance and Source Inspection

WELDING INSPECTION REPORT

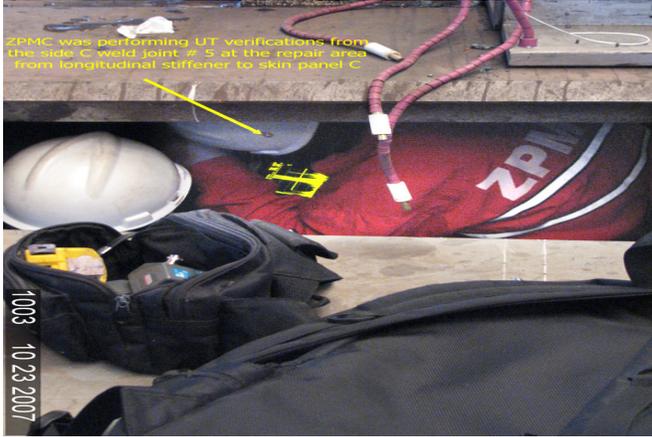
Item	Description	WBS	Dwg No.	Status
1	Ultrasonic Testing (UT) to the weld repair at the Skin C weld joint # 5, 114 M The QA inspector witnessed ZPMC Quality Control inspector Mr. Li Li Ming performing UT at the junction of the skin C and longitudinal stiffener subassembly MA111, weld joint # 5. The QA inspector observed that after completion, Mr. Li Li Ming wrote on the steel that the weld repair area was acceptable. The QA inspector observed UT evaluations appeared to be in general compliance with the contract documents. Later, the QA inspector observed ZPMC re-scanning the weld repair area. ZPMC QA inspector Mr. Fu Yu Hong informed the QA inspector that after ZPMC re-evaluating the weld repair area, ZPMC determined that the weld repair area had a rejectable indication with approximately 30 mm of length.

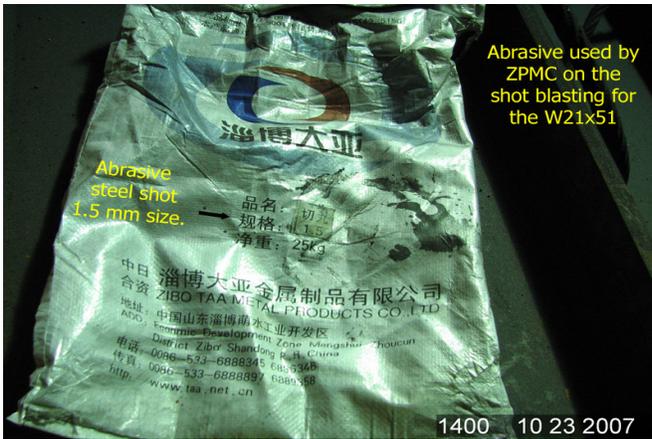
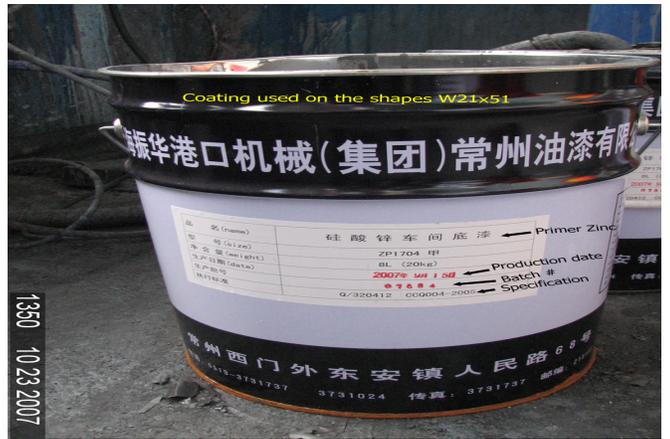
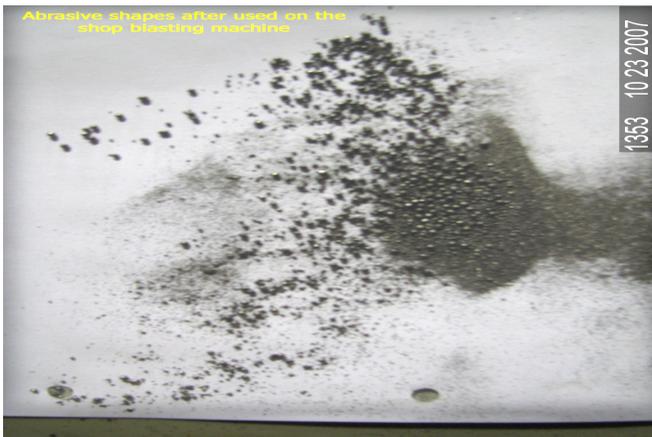
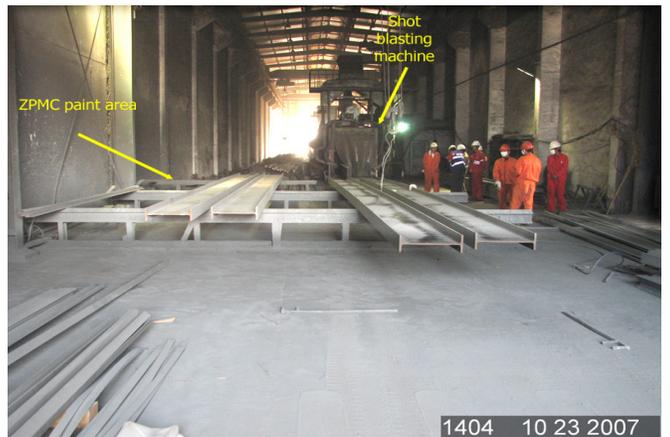
2 Sand Blasting and painting on the W21x51 OBG Fabrication

The QA inspector visited the ZPMC paint shop. The QA inspector observed that ZPMC was blasting the surfaces of the shapes designated as W21x57 (shapes that ZPMC would use on OBG fabrication) thru two (2) shot blasting machine located on series. The surface obtained appeared to be in general compliance with blast profile SSPC-6 for commercial blasting. See digital photograph below. The QA inspector had a conversation with ZPMC QA inspector Mr. Xu Jun. Mr. Xu Jun relayed that the abrasive used for blasting the W shapes was made 1.5 mm diameter steel shots. See below the bag with the abrasive specification used by ZPMC and the primer coating (gray inorganic zinc) container. In addition, photos with ZPMC's paint and blast areas.

Note: ZPMC would coat the W shapes with the intent of protecting the parts for corrosion during storage.

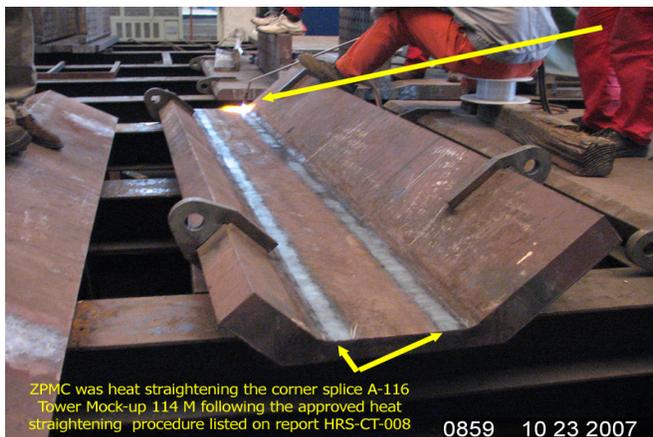
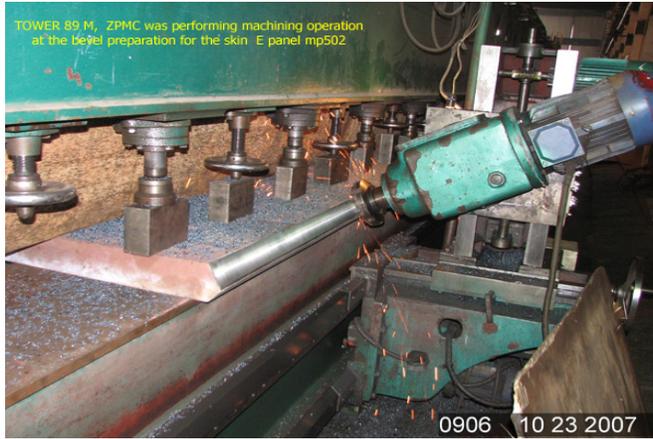
4 Tower 89 Meter Elevation Milling operations

The QA inspector observed ZPMC performing milling operations to the bevels before fitting operations at the skin panel E, subassembly MA38 plate mp502. The photograph below shows the skin E during milling operations at the bevel preparation.
