DEPARTMENT OF TRANSPORTATION

Quality Assurance and Source Inspection

Contract #: 04-0120F4Cty: SF/ALA Rte: 80 PM: 13.2/13.9File #: 69.28**WELDING INSPECTION REPORT****Resident Engineer:** Pursell, Gary**Address:** 333 Burma Road**City:** Oakland, CA 94607**Report No:** WIR-000767**Date Inspected:** 30-Oct-2007**Project Name:** SAS Superstructure**OSM Arrival Time:** 630**Prime Contractor:** American Bridge/Fluor Enterprises, a JV**OSM Departure Time:** 1530**Contractor:** Zhenhua Port Machinery Company, Ltd (ZPMC), Changxing Island **Location:** Shanghai, China**CWI Name:** Fu Guogang**CWI Present:** Yes No**Inspected CWI report:** Yes No N/A**Rod Oven in Use:** Yes No N/A**Electrode to specification:** Yes No N/A**Weld Procedures Followed:** Yes No N/A**Qualified Welders:** Yes No N/A**Verified Joint Fit-up:** Yes No N/A**Approved Drawings:** Yes No N/A**Approved WPS:** Yes No N/A**Delayed / Cancelled:** Yes No N/A**Bridge No:** 34-0006**Component:** OBG weld trial**Summary of Items Observed:**

WELDING INSPECTION REPORT

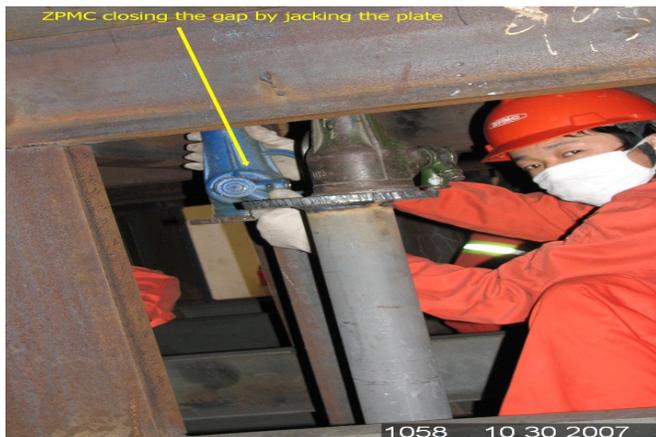
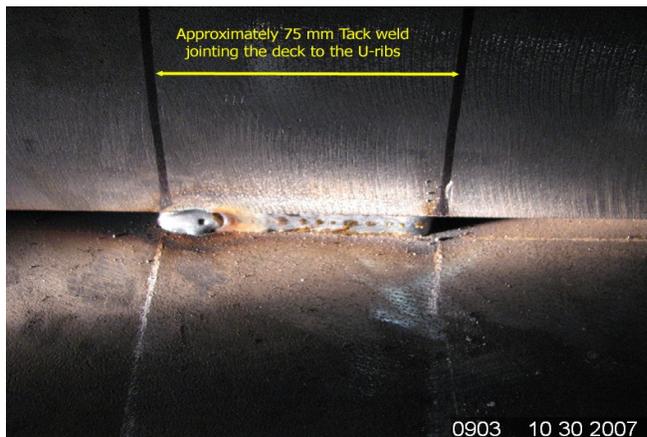
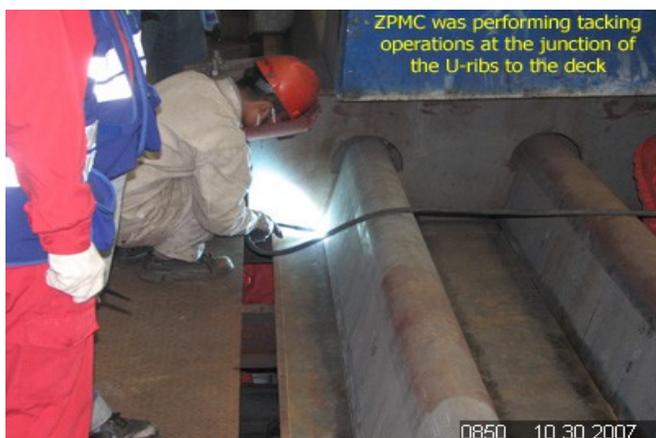
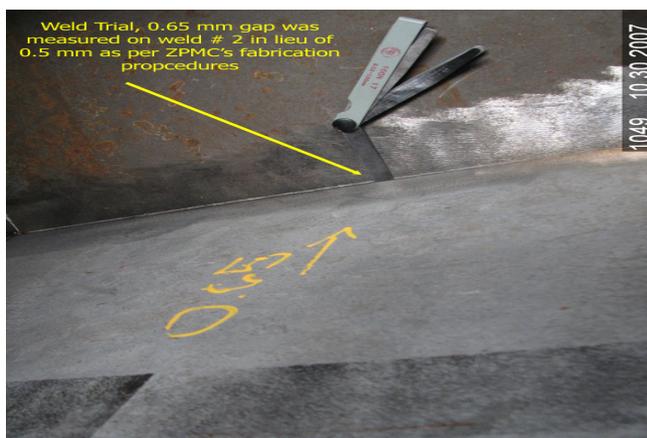
The QA inspector was performing fit-up verifications on the second ZPMC weld trial for the fabrication of the mock-up for the orthotropic box girder (OBG) at the junction of deck panel to U-ribs U-73, U-01, U-75, U-02 and U-05. The QA inspector performed random verifications of the gaps between the deck and the U-ribs, tack welds spacing and length at the ZPMC second Weld Trial. The QA inspector observed that gaps between the deck panel and the U-ribs exceed 0.65 mm in four locations at the weld joint # 2, 6, 3 and 10. The QA inspector had a conversation with ZPMC QA inspector Mr. Fu Yu Hong. The QA inspector showed to Mr. Fu Yu Hong that the second weld trial had gaps exceeding the maximum required of 0.5 mm on ZPMC's fabrication procedure. Mr. Fu Yu Hong relayed to the QA inspector that ZPMC representative was going to ask the ZPMC's technical department. The QA inspector had a conversation Caltrans Task Leader Robert Cuellar and David McClary about gaps on the weld trial exceeding the maximum allow in the ZPMC's fabrication procedure. After, Mr. David McClary conversation with ABF representative Mr. Peter Ferguson, Mr. Peter Ferguson relayed to Mr. David McClary that ZPMC planned to proceed welding the second OBG weld trial with gaps exceeding the minimum required by the fabrication procedure to demonstrate that welding with gaps exceeding the maximum could still obtain satisfactory results and that ZPMC on the actual production would keep 0.5 mm gap as the maximum tolerance. The QA inspector observed welder Yang Yong Zheng performing tacking operations with the gas metal arc welding (GMAW) process. The QA inspector verified the welding parameters. The QA found that the welding parameters appeared to be in general compliance with the welding procedure specification (WPS)-B-T 2342 U2

(U-ribs). The digital photographs show ZPMC fit-up activities and the area at the weld # 2 U rib U-73 where the QA inspector found a gap greater than 0.5 mm.
