Contract #: 04-0120F4Cty: SF/ALA Rte: 80 PM: 13.2/13.9File #: 69.28**WELDING INSPECTION REPORT****Resident Engineer:** Pursell, Gary**Address:** 333 Burma Road**City:** Oakland, CA 94607**Report No:** WIR-000772**Date Inspected:** 16-Oct-2007**Project Name:** SAS Superstructure**OSM Arrival Time:** 630**Prime Contractor:** American Bridge/Fluor Enterprises, a JV**OSM Departure Time:** 1530**Contractor:** Zhenhua Port Machinery Company, Ltd (ZPMC), Changxing Island **Location:** Shanghai, China**CWI Name:** Fu Guogang**CWI Present:** Yes No**Inspected CWI report:** Yes No N/A**Rod Oven in Use:** Yes No N/A**Electrode to specification:** Yes No N/A**Weld Procedures Followed:** Yes No N/A**Qualified Welders:** Yes No N/A**Verified Joint Fit-up:** Yes No N/A**Approved Drawings:** Yes No N/A**Approved WPS:** Yes No N/A**Delayed / Cancelled:** Yes No N/A**Bridge No:** 34-0006**Component:** OBG weld trial**Summary of Items Observed:**

CALTRANS Quality Assurance (QA) Inspector, Alfredo Acuna was present for the fabrication of the 10 meters U-ribs Weld Trial scheduled for this project at the ZPMC facility in Shanghai, China for the San Francisco Oakland Bay Self Anchored Suspension Bridge.

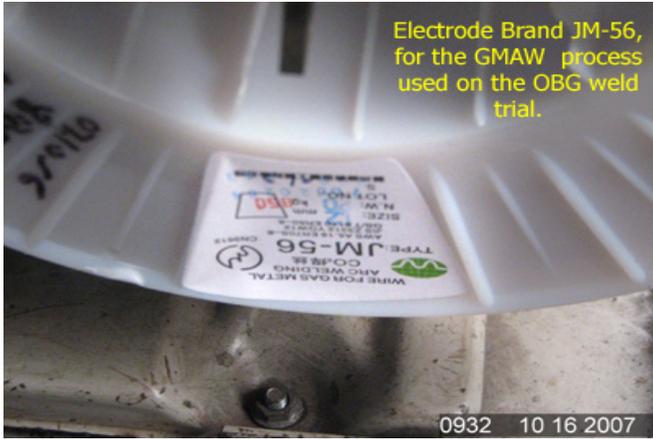
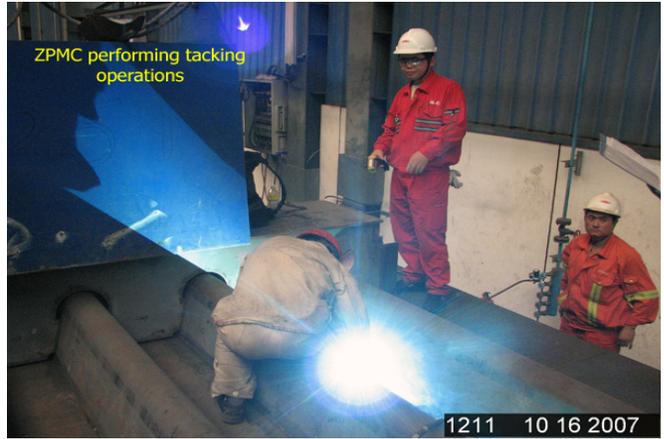
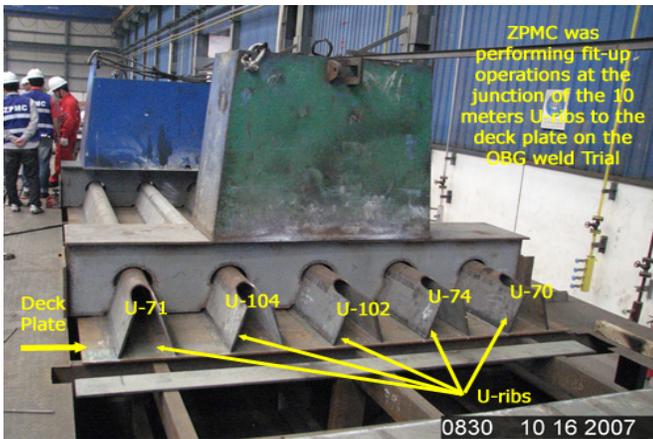
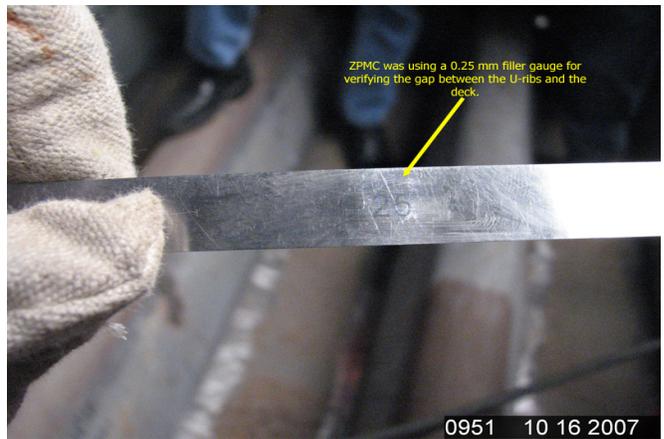
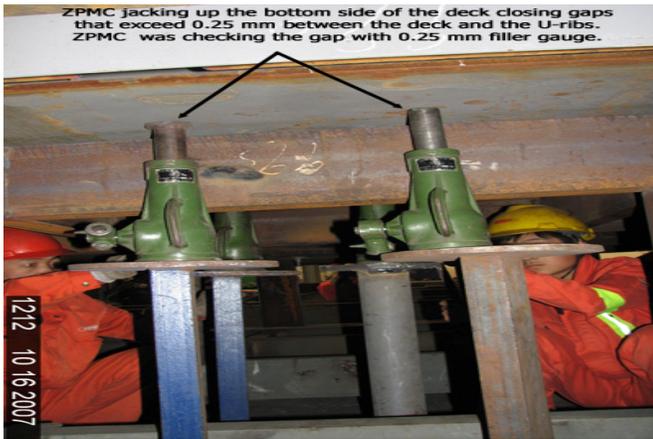
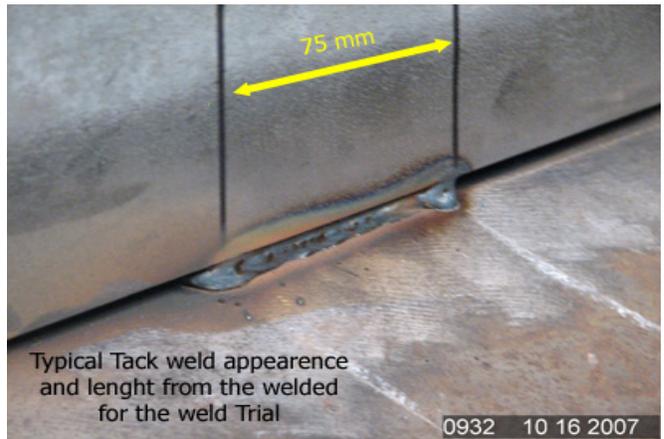
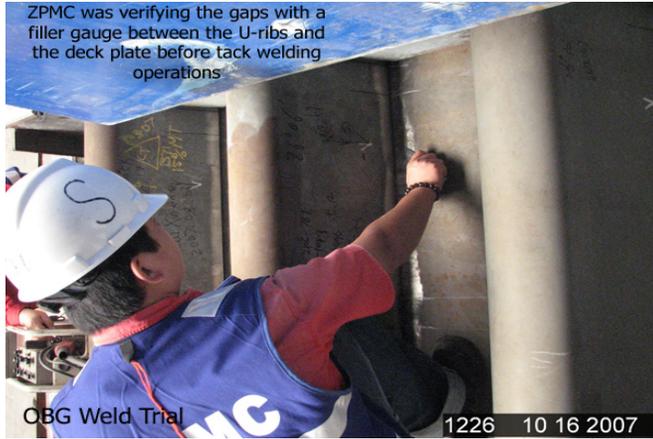
The QA inspector was at the OBG mock-up performing fit-up verifications at the junction of deck to u-ribs U-70, U-74, U-102, U-104 and U-71. The QA inspector performed random verifications of the gaps between the deck and the U-ribs, tack welds spacing and length. The gaps between the deck and the U-ribs appeared not to exceed 0.25 mm. The QA inspector had a conversation with the ZPMC QA inspector Mr. Fu Yu Hong. Mr. Fu relayed that ZPMC was intended to closed the gap down to less than 0.25 mm because ZPMC was expecting that the gaps would open after the pressure from the weights (2.5, 10 and 2.3 Metric Tons) were release. The QA inspector observed welder Yang Yong Zheng performing tacking operations with the Gas metal arc welding (GMAW) process. The QA inspector verified the welding parameters. The QA found that the welding parameters appeared to be in compliance with the welding procedure specification (WPS)-B-T2342 U2 (Uribs). The digital photographs below show the fit-up activities performed by ZPMC on this date.
