**DEPARTMENT OF TRANSPORTATION**

Contract #: 04-0120F4Cty: SF/ALA Rte: 80 PM: 13.2/13.9File #: 69.28**WELDING INSPECTION REPORT****Resident Engineer:** Pursell, Gary**Address:** 333 Burma Road**City:** Oakland, CA 94607**Report No:** WIR-000775**Date Inspected:** 02-Nov-2007**Project Name:** SAS Superstructure**OSM Arrival Time:** 630**Prime Contractor:** American Bridge/Fluor Enterprises, a JV**OSM Departure Time:** 1500**Contractor:** Zhenhua Port Machinery Company, Ltd (ZPMC), Changxing Island **Location:** Shanghai, China

<b>CWI Name:</b>	NA	<b>CWI Present:</b>	Yes	No
<b>Inspected CWI report:</b>	Yes No N/A	<b>Rod Oven in Use:</b>	Yes No N/A	
<b>Electrode to specification:</b>	Yes No N/A	<b>Weld Procedures Followed:</b>	Yes No N/A	
<b>Qualified Welders:</b>	Yes No N/A	<b>Verified Joint Fit-up:</b>	Yes No N/A	
<b>Approved Drawings:</b>	Yes No N/A	<b>Approved WPS:</b>	Yes No N/A	
		<b>Delayed / Cancelled:</b>	Yes No N/A	
<b>Bridge No:</b>	34-0006	<b>Component:</b>	OBG U-Rib Trial Assembly

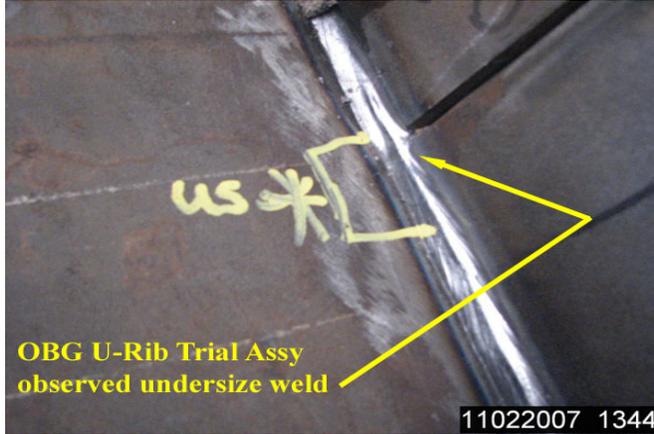
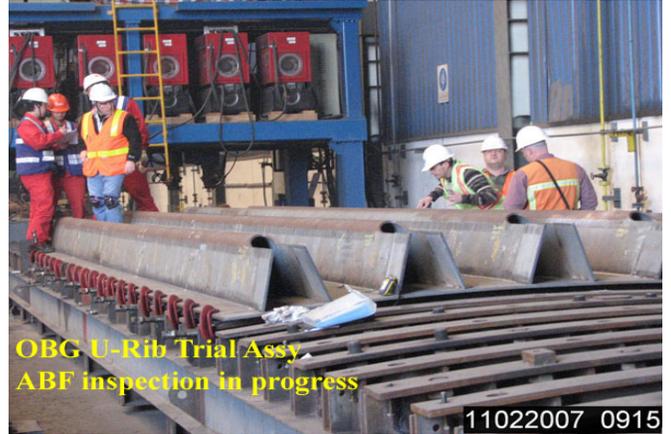
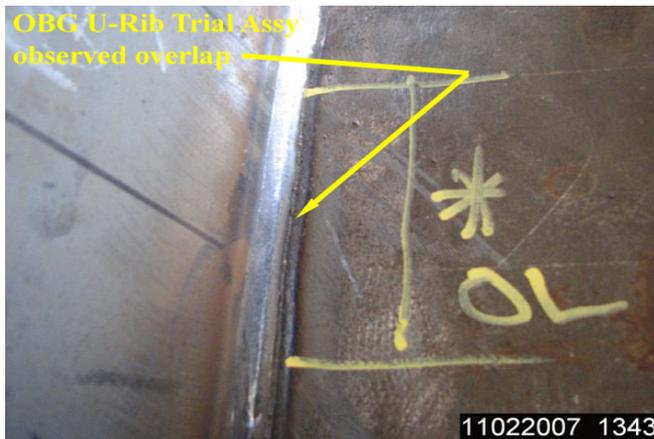
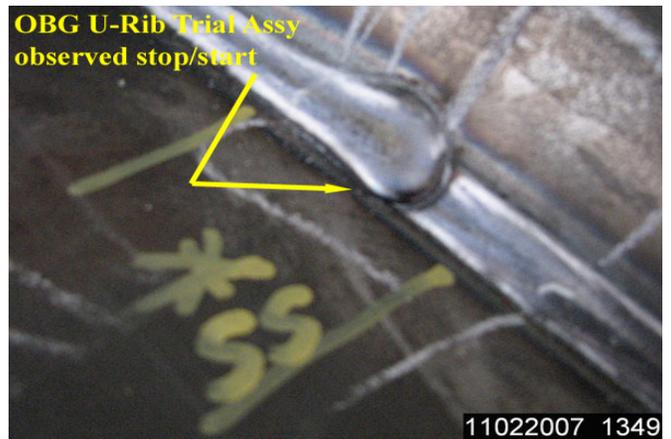
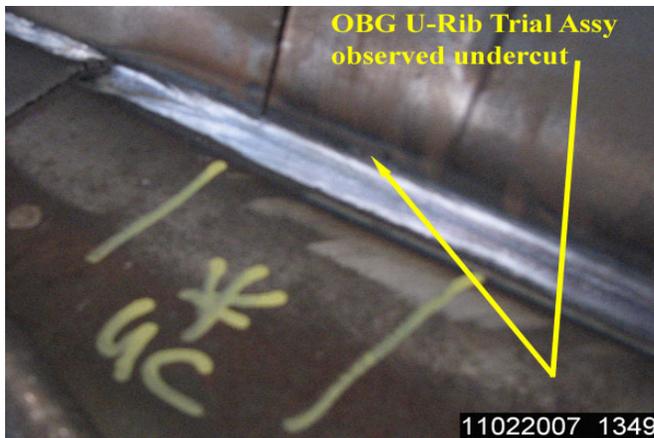
would find it. After hearing about Caltrans inspection results, Mr. Peterson left the building and then returned, about an hour later with Mr. Peter Ferguson ABF representative. Mr. Peterson stated, along with Mr. Ferguson, that they are of the opinion that the overlap, maybe weld convexity. Caltrans QA Inspector informed Mr. Peterson and Mr. Ferguson that the findings by Caltrans would be reported as overlap, but that this is a sufficient enough finding that it needs to be reported, and that Caltrans selected macro-etch may be randomly taken from these locations. The following digital pictures illustrate overlap, undercut and non-fusion.
