DEPARTMENT OF TRANSPORTATION

Quality Assurance and Source Inspection

Contract #: 04-0120F4Cty: SF/ALA Rte: 80 PM: 13.2/13.9File #: 69.28**WELDING INSPECTION REPORT****Resident Engineer:** Pursell, Gary**Address:** 333 Burma Road**City:** Oakland, CA 94607**Report No:** WIR-003972**Date Inspected:** 30-Aug-2008**Project Name:** SAS Superstructure**OSM Arrival Time:** 700**Prime Contractor:** American Bridge/Fluor Enterprises, a JV**OSM Departure Time:** 1500**Contractor:** Zhenhua Port Machinery Company, Ltd (ZPMC), Changxing Island **Location:** Shanghai, China**CWI Name:** not observed**CWI Present:** Yes No**Inspected CWI report:** Yes No N/A**Rod Oven in Use:** Yes No N/A**Electrode to specification:** Yes No N/A**Weld Procedures Followed:** Yes No N/A**Qualified Welders:** Yes No N/A**Verified Joint Fit-up:** Yes No N/A**Approved Drawings:** Yes No N/A**Approved WPS:** Yes No N/A**Delayed / Cancelled:** Yes No N/A**Bridge No:** 34-0006**Component:** OBG assembly, lap plates**Summary of Items Observed:****OBG Sub Assembly - Bay 1**

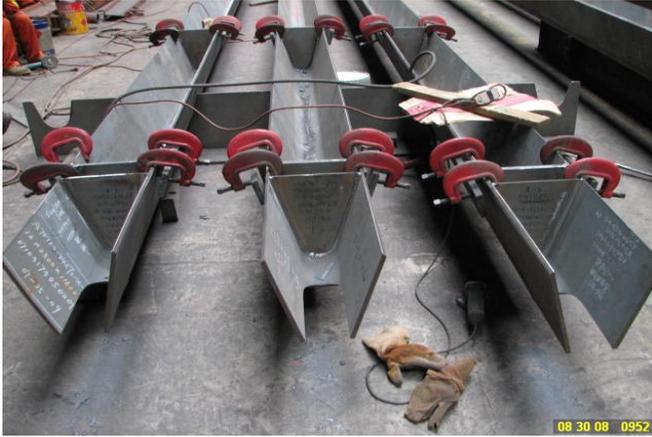
QA Inspector randomly observed deck panels in various stages of fabrication and approximately 45 ZPMC workers performing the following: FCAW - G of three - 19mm stiffener plates inboard of the 8mm stiffeners previously observed inside the U-ribs (see photo below); cleaning of deck plates in layout pattern where the U-rib welds will be; grinding of root pass of U-rib to deck plate welds on DP357-001. Present in this bay was ABF QC Chang Bao Qian (ABF QC-1). No CWI was observed in this bay. Items observed appeared to comply with project specifications.
