Contract #: 04-0120F4Cty: SF/ALA Rte: 80 PM: 13.2/13.9File #: 69.28**WELDING INSPECTION REPORT****Resident Engineer:** Pursell, Gary**Address:** 333 Burma Road**City:** Oakland, CA 94607**Report No:** WIR-004179**Date Inspected:** 29-Sep-2008**Project Name:** SAS Superstructure**OSM Arrival Time:** 700**Prime Contractor:** American Bridge/Fluor Enterprises, a JV**OSM Departure Time:** 1700**Contractor:** Zhenhua Port Machinery Company, Ltd (ZPMC), Changxing Island **Location:** Shanghai, China**CWI Name:** Sun Wei**CWI Present:** Yes No**Inspected CWI report:** Yes No N/A**Rod Oven in Use:** Yes No N/A**Electrode to specification:** Yes No N/A**Weld Procedures Followed:** Yes No N/A**Qualified Welders:** Yes No N/A**Verified Joint Fit-up:** Yes No N/A**Approved Drawings:** Yes No N/A**Approved WPS:** Yes No N/A**Delayed / Cancelled:** Yes No N/A**Bridge No:** 34-0006**Component:** Tower**Summary of Items Observed:**

East Shaft, Skin A, Lift 1

East Shaft, Skin E, Lift 1

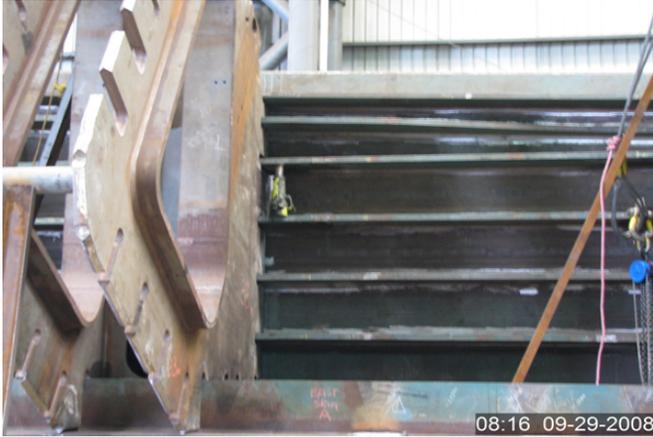
The Quality Assurance Inspector observed several 10 ton hydraulic jacking devices being utilized to aid in the erection and fit up of the skin plate to diaphragm connections. ZPMC dimension control plan makes no such mention of the procedure. Caltrans Assistant Structures Materials Representative Josh Ishibashi was notified of the discrepancy.
