Contract #: 04-0120F4Cty: SF/ALA Rte: 80 PM: 13.2/13.9File #: 69.28**WELDING INSPECTION REPORT****Resident Engineer:** Pursell, Gary**Address:** 333 Burma Road**City:** Oakland, CA 94607**Report No:** WIR-004225**Date Inspected:** 19-Sep-2008**Project Name:** SAS Superstructure**OSM Arrival Time:** 700**Prime Contractor:** American Bridge/Fluor Enterprises, a JV**OSM Departure Time:** 1530**Contractor:** Zhenhua Port Machinery Company, Ltd (ZPMC), Changxing Island **Location:** Shanghai, China**CWI Name:** See below**CWI Present:** Yes No**Inspected CWI report:** Yes No N/A**Rod Oven in Use:** Yes No N/A**Electrode to specification:** Yes No N/A**Weld Procedures Followed:** Yes No N/A**Qualified Welders:** Yes No N/A**Verified Joint Fit-up:** Yes No N/A**Approved Drawings:** Yes No N/A**Approved WPS:** Yes No N/A**Delayed / Cancelled:** Yes No N/A**Bridge No:** 34-0006**Component:** Tower & OBG**Summary of Items Observed:**

WELDING INSPECTION REPORT

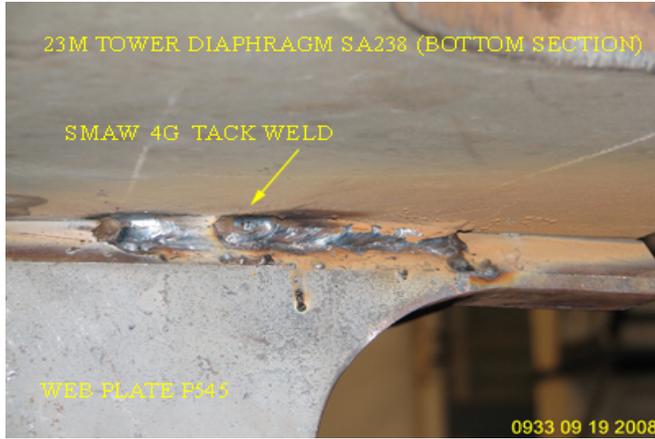
The QA Inspector randomly observed ZPMC welders Li Jian ID Number 067829 and Lv Peng ID Number 048617, utilizing the SMAW Process in the 4G (Overhead Groove) Position with ZPMC WPS WPS-B-T-3314 to tack weld Web Plate piece mark p545 to 23M (W) Bottom Tower Diaphragm SA238 at WJ's WSD1-SA238B/B-1/2. The QA Inspector randomly observed ZPMC QC under the supervision of ZPMC CWI Yu Dong Ping monitoring weld parameters. The weld parameters appeared to comply with contract requirements. The attached photograph provides additional detail.

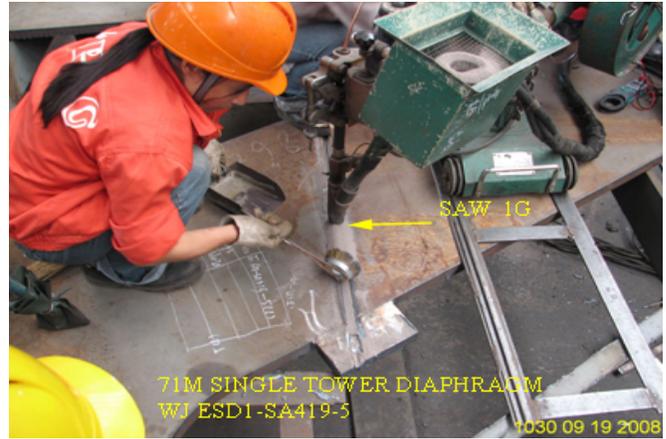
The QA Inspector randomly observed ZPMC welder Gu Cai Hong ID Number 053748, utilizing the Submerged Arc Welding SAW Process in the 1G(Flat Groove) Position with ZPMC WPS WPS-B-T-2321-B-P3-S-2, to weld the butt splice between piece marks p1541 and SA419 of 71M Single Tower Diaphragm SA419 at WJ ESD1-SA419-3 and 5. The QA Inspector randomly observed ZPMC QC under the supervision of ZPMC CWI Yu Dong Ping, monitoring weld parameters. The QA Inspector also randomly monitored weld parameters and recorded them as follows: 580 amps, 28.5 volts with a travel speed of 515 millimeters (mm) per minute for WJ 3 and 586 amps, 29 volts with a travel speed of 517 mm per minute. The weld parameters appeared to comply with contract requirements. The attached photograph provides additional detail.
