DEPARTMENT OF TRANSPORTATION

Quality Assurance and Source Inspection

Contract #: 04-0120F4Cty: SF/ALA Rte: 80 PM: 13.2/13.9File #: 70.28**WELDING INSPECTION REPORT****Resident Engineer:** Pursell, Gary**Address:** 333 Burma Road**City:** Oakland, CA 94607**Report No:** WIR-004285**Date Inspected:** 23-Oct-2008**Project Name:** SAS Superstructure**OSM Arrival Time:** 2200**Prime Contractor:** American Bridge/Fluor Enterprises, a JV**OSM Departure Time:** 800**Contractor:** Japan Steel Works**Location:** Muroran, Japan**CWI Name:** Pan Han**CWI Present:** Yes No**Inspected CWI report:** Yes No N/A**Rod Oven in Use:** Yes No N/A**Electrode to specification:** Yes No N/A**Weld Procedures Followed:** Yes No N/A**Qualified Welders:** Yes No N/A**Verified Joint Fit-up:** Yes No N/A**Approved Drawings:** Yes No N/A**Approved WPS:** Yes No N/A**Delayed / Cancelled:** Yes No N/A**Bridge No:** 34-0006**Component:** Tower, Deviation and Jacking Saddles**Summary of Items Observed:**

On this date OSM Quality Assurance (QA) Representative Daniel L. Reyes was present during the welding of the structural steel components regarding the West Deviation Saddles relative to this project. The followin

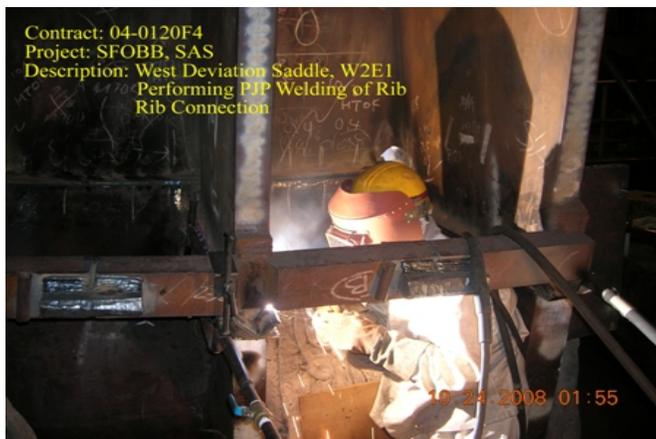
The PJP groove welding was performed on the structural steel rib to casting rib connections identified as E1Y-14U, E1Y-15U, E1Y-16U and E1Y-17U-2.

See Weld Joints in Progress Inspected, below, in regards to QA observation of the welding parameters recorded during this shift and digital photograph illustrates the observations of the activities performed on this date.
