Contract #: 04-0120F4Cty: SF/ALA Rte: 80 PM: 13.2/13.9File #: 69.28**WELDING INSPECTION REPORT****Resident Engineer:** Pursell, Gary**Address:** 333 Burma Road**City:** Oakland, CA 94607**Report No:** WIR-004426**Date Inspected:** 19-Oct-2008**Project Name:** SAS Superstructure**OSM Arrival Time:** 630**Prime Contractor:** American Bridge/Fluor Enterprises, a JV**OSM Departure Time:** 1530**Contractor:** Zhenhua Port Machinery Company, Ltd (ZPMC), Changxing Island **Location:** Shanghai, China

Bridge No: 34-0006**Component:** Tower & OBG**Summary of Items Observed:**

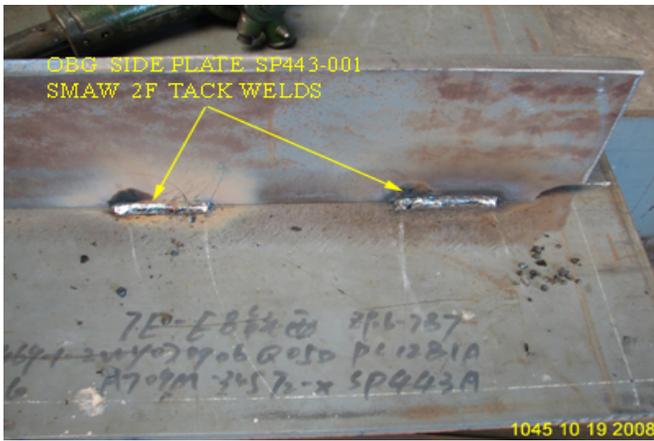
The QA Inspector randomly observed ZPMC welder Xiao Lin ID 049485, utilizing the Shielded Metal Arc Welding (SMAW) Process in the 2F (Horizontal Fillet) Position with ZPMC Weld Procedure Specification (WPS) WPS-2112-FCM, to tack weld I-Ribs to Side Plate SP443-001 Weld Joint (WJ) Numbers 001/002. The QA Inspector randomly observed ZPMC QC under the supervision of ZPMC CWI Wu Ming Kai, monitoring weld parameters. The weld parameters appeared to comply with contract requirements. The attached photograph provides additional detail.
