**DEPARTMENT OF TRANSPORTATION**

Contract #: 04-0120F4Cty: SF/ALA Rte: 80 PM: 13.2/13.9File #: 69.28**WELDING INSPECTION REPORT****Resident Engineer:** Pursell, Gary**Address:** 333 Burma Road**City:** Oakland, CA 94607**Report No:** WIR-004508**Date Inspected:** 30-Oct-2008**Project Name:** SAS Superstructure**OSM Arrival Time:** 1400**Prime Contractor:** American Bridge/Fluor Enterprises, a JV**OSM Departure Time:** 2300**Contractor:** Zhenhua Port Machinery Company, Ltd (ZPMC), Changxing Island **Location:** Shanghai China**CWI Name:** Liu Yang / Sun Bo**CWI Present:** Yes No**Inspected CWI report:** Yes No N/A**Rod Oven in Use:** Yes No N/A**Electrode to specification:** Yes No N/A**Weld Procedures Followed:** Yes No N/A**Qualified Welders:** Yes No N/A**Verified Joint Fit-up:** Yes No N/A**Approved Drawings:** Yes No N/A**Approved WPS:** Yes No N/A**Delayed / Cancelled:** Yes No N/A**Bridge No:** 34-0006**Component:** Tower/OBG**Summary of Items Observed:**

89M Mock-up

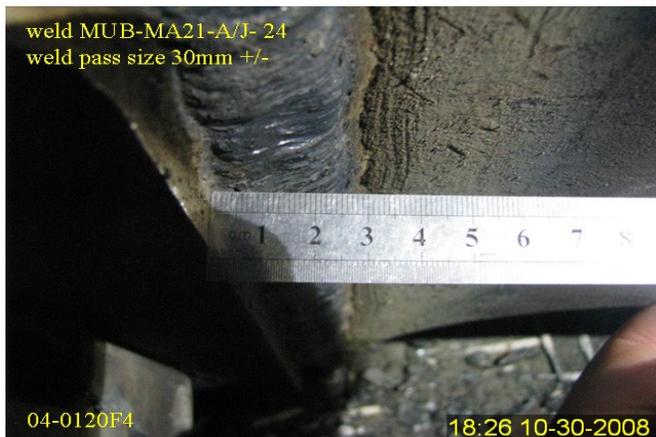
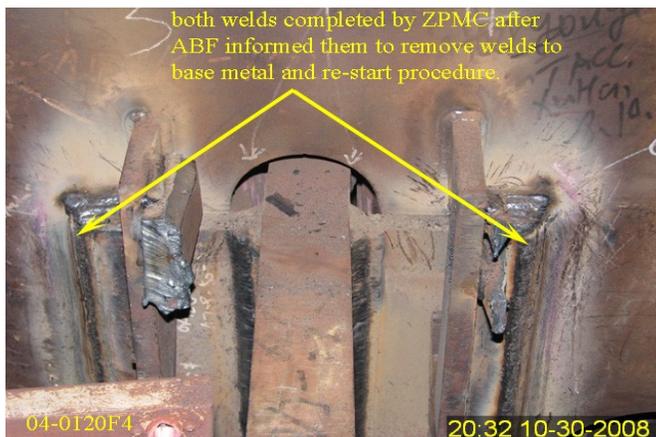
The QA Inspector randomly observed ZPMC personnel performing grinding of repairs for the Orthotropic Box Girder (OBG) deck panel Partial Joint Penetration (PJP) welds. This QA inspector along with ZPMC and ABF personnel performed the 3 party initial visual inspections. All 3 parties agreed on the areas to be repaired and ZPMC continued working on these locations. The yellow ABF tracking tag affixed to the deck panel was signed by all 3 parties. The deck panels inspected were DP590-001, DP585-001 and DP585-002. Certified Welding Inspector for ZPMC Li Sun Bo (night shift) were present at this location for the monitoring of the deck repairs and inspection. Also noted in bay 3 to monitor deck panel repairs were ABF personnel Wang Wei.
