**DEPARTMENT OF TRANSPORTATION**

Contract #: 04-0120F4Cty: SF/ALA Rte: 80 PM: 13.2/13.9File #: 70.28**WELDING INSPECTION REPORT****Resident Engineer:** Pursell, Gary**Address:** 333 Burma Road**City:** Oakland, CA 94607**Report No:** WIR-004558**Date Inspected:** 05-Nov-2008**Project Name:** SAS Superstructure**OSM Arrival Time:** 800**Prime Contractor:** American Bridge/Fluor Enterprises, a JV**OSM Departure Time:** 1800**Contractor:** Japan Steel Works**Location:** Muroran, Japan

**Component:** Tower, Deviation and Jacking Saddles

## WELDING INSPECTION REPORT

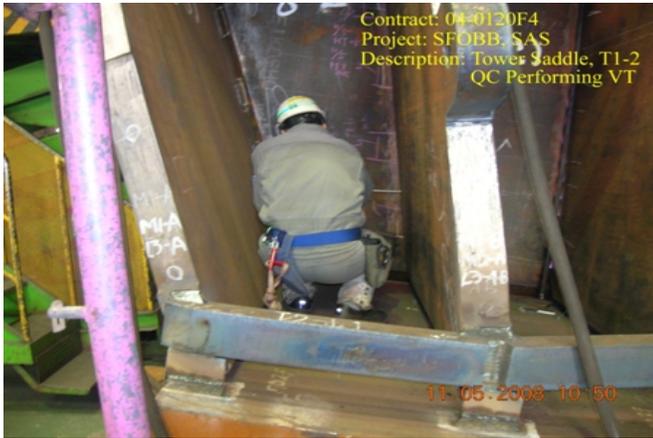
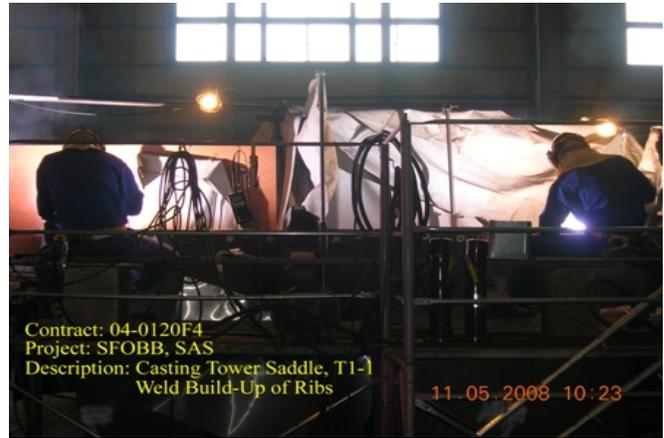
At the start of the shift the QA inspector traveled to the shop to observe the scheduled work performed on the casting stem and rib on the Tower Saddle identified as T1-1. The weld build-up was performed on the casting ribs which were identified as 7Y-5U-2, 7Y-8U, 7Y-9U-2 and 7Y-9U-3 utilizing the Welding Procedure Specification (WPS) SJ-3012-1-1. The WPS was also used by the Intertek Testing Service (ITS) Quality Control (QC) Inspector Chung Fu-Kuan as a reference during QC verification of the Alternating Current (AC) welding parameters. The SMAW process was performed by the following JSW welding personnel; Kato Ryota ID 07-4510, Yoshita Nakano 08-2011 and Kazuya Iwamoto ID 07-4366. The tower saddle was positioned so that the performance of the welding was in the flat position with the work in the horizontal plane and the weld metal deposited from above.

Penetration (PJP) groove welds on the Tower Saddle identified as T1-2. The welding process utilized appeared to be the Shielded Metal Arc Welding (SMAW) and was performed by the following Japan Steel Works, Ltd. (JSW) welding personnel; Kobayashi Kouzou ID 08-5023 and Kato Makoto ID 08-5018. The Welding Procedure Specification (WPS) utilized by the welders appeared to be SJ-3012-2 which was also used by the Intertek Testing Service (ITS) Quality Control (QC) Inspector Chung Fu-Kuan as a reference during verification of the welding parameters. It was also noted by the QA inspector that JSW Distortion Control Plan identified as Document No. SJ-3151Rev. 3 was utilized in conjunction with the WPS. The welding of the PJP groove weld was performed on the structural steel end plate to base plate connection identified as weld numbers 8Y-10V (2-2) and 8Y-10V (2-3).

Later in the shift the QA inspector observed that Magnetic Particle Testing (MPT) was conducted on the West Deviation Saddle casting identified as W2E2. It appears that several relevant indications were noted by NIS/QC technician, Makoto Wada that will require the excavation process. At the time of the QA inspector's observation the QC technician had concluded the MPT and no other testing was performed.

The following digital photographs illustrate the observations of the activities performed on this date.
