DEPARTMENT OF TRANSPORTATION

Quality Assurance and Source Inspection

Contract #: 04-0120F4Cty: SF/ALA Rte: 80 PM: 13.2/13.9File #: 70.28**WELDING INSPECTION REPORT****Resident Engineer:** Pursell, Gary**Address:** 333 Burma Road**City:** Oakland, CA 94607**Report No:** WIR-004563**Date Inspected:** 08-Nov-2008**Project Name:** SAS Superstructure**OSM Arrival Time:** 800**Prime Contractor:** American Bridge/Fluor Enterprises, a JV**OSM Departure Time:** 1600**Contractor:** Japan Steel Works**Location:** Muroran, Japan**CWI Name:** Chung Fu-Kuan**CWI Present:** Yes No**Inspected CWI report:** Yes No N/A**Rod Oven in Use:** Yes No N/A**Electrode to specification:** Yes No N/A**Weld Procedures Followed:** Yes No N/A**Qualified Welders:** Yes No N/A**Verified Joint Fit-up:** Yes No N/A**Approved Drawings:** Yes No N/A**Approved WPS:** Yes No N/A**Delayed / Cancelled:** Yes No N/A**Bridge No:** 34-0006**Component:** Tower, Deviation and Jacking Saddles**Summary of Items Observed:**

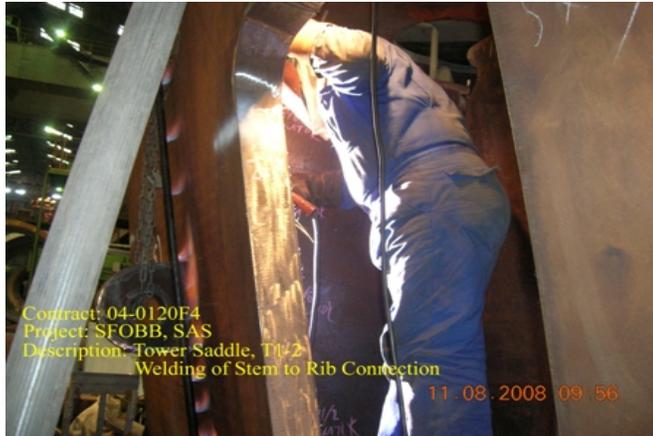
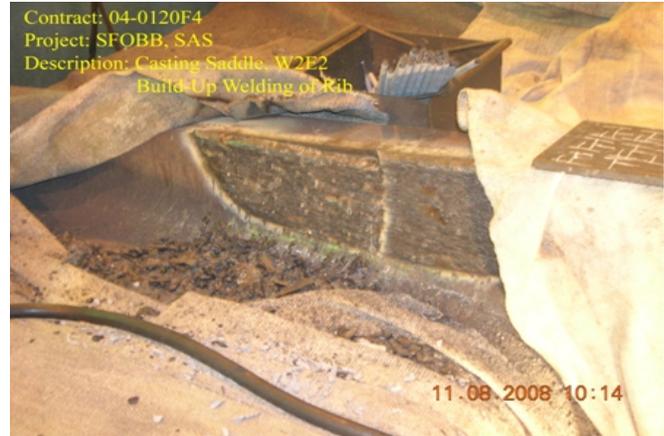
At the start of the shift, the QA inspector traveled to the fabrication shop to observe the scheduled welding and the Magnetic Particle Testing (MPT) of the Partial Joint Penetration (PJP) groove welds on the Tower Saddle identified as T1-2. The welding process utilized appeared to be the Shielded Metal Arc Welding (SMAW) and was performed by the following JSW welding personnel; Kobayashi Kouzou ID 08-5023 and Kato Makoto ID 08-5018. The Welding Procedure Specification (WPS) utilized by the welders appeared to be SJ-3012-2 which was also used by the Intertek Testing Service (ITS) Quality Control (QC) Inspector Chung Fu-Kuan as a reference during verification of the welding parameters. It was also noted by the QA inspector that JSW Distortion Control Plan identified as Document No. SJ-3151Rev. 3 was utilized in conjunction with the WPS. The welding of the PJP groove weld was performed on the rib to stem connection identified as weld numbers 8Y-5V (2-3), 8Y-8V (2-3) and 8Y-12V (2-2).

Later in the shift, the QA inspector traveled to the Foundry Shop to observe the continued repair welding of the rib build-up areas on the West Deviation Saddle Casting identified as W2E2. The repair welding is being conducted at Lane 1 of the Foundry Shop at the designated area identified as “The Gouging and Grinding Area.” The welding was performed on the rib identified as Rib 6U by JSW welding personnel Takenami Akira ID 06-8001 utilizing the SMAW process as per the WPS SJ-3026-2. The WPS was also used by the Welding Engineer, Tomio Imai as a reference during the verification of the welding parameters and surface temperatures.

See Weld Joints in Progress Inspected on page 3 of this report in regards to QA observation of the welding parameters recorded during this shift and the following digital photographs illustrates the observations of the activities performed on this date.
