DEPARTMENT OF TRANSPORTATION

Contract #: 04-0120F4Cty: SF/ALA Rte: 80 PM: 13.2/13.9File #: 70.28**WELDING INSPECTION REPORT****Resident Engineer:** Pursell, Gary**Address:** 333 Burma Road**City:** Oakland, CA 94607**Report No:** WIR-005093**Date Inspected:** 16-Dec-2008**Project Name:** SAS Superstructure**OSM Arrival Time:** 830**Prime Contractor:** American Bridge/Fluor Enterprises, a JV**OSM Departure Time:** 1830**Contractor:** Japan Steel Works**Location:** Muroran, Japan**CWI Name:** Chung Kuan**CWI Present:** Yes No**Inspected CWI report:** Yes No N/A**Rod Oven in Use:** Yes No N/A**Electrode to specification:** Yes No N/A**Weld Procedures Followed:** Yes No N/A**Qualified Welders:** Yes No N/A**Verified Joint Fit-up:** Yes No N/A**Approved Drawings:** Yes No N/A**Approved WPS:** Yes No N/A**Delayed / Cancelled:** Yes No N/A**Bridge No:** 34-0006**Component:** Tower, Jacking and Deviation Saddles**Summary of Items Observed:**

WELDING INSPECTION REPORT

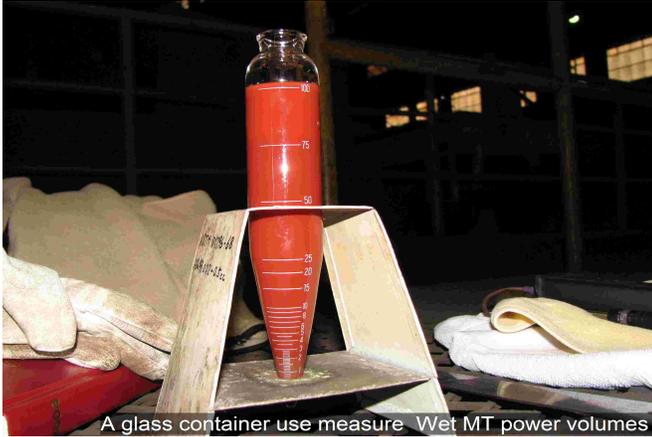
A glass container use measure Wet MT power volumes

First, the technician used 10 liter water mixed with 1kg non-fluorescent red magnetic particles in a container for 10 minutes. Next, the mixed wet suspension particle samples have been filled into a measurable glass container for settling volumes standard. The settling volumes have showed on glass container as is 2.3 ml (ASME standard from 1.2 ml to 2.4 ml per 100ml). Then, the technician performed wet MT test, the wet suspension particle carrier by a squeeze bottle. The wet suspension particle is gently sprayed out and flowed over the surface of the test part quickly and easily covered with a relatively uniform layer of particles. The magnetizing force applied immediately after applying the suspension of magnetic particles. The use of wet suspension particles is useful for detecting slightly discontinuities on the smooth surface such as after machining. The discontinuity is forming by magnetic leakage fields and visible indication. The West Deviation Saddle Casting W2W1 appeared to be approximately 80% complete at this time and no relative indication was found on the test surface for today. The wet MT test will continue on 2nd shift.

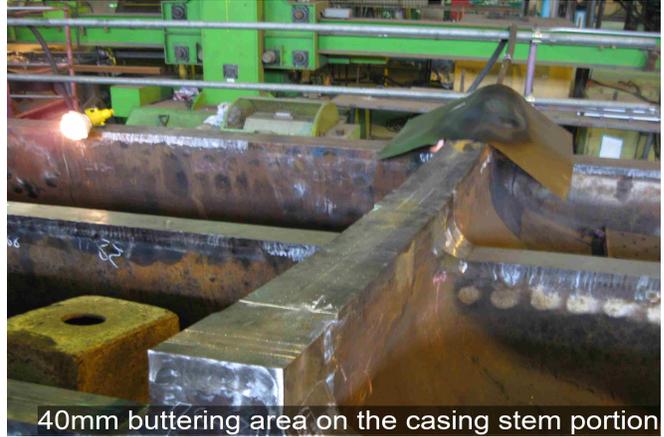
40mm buttering area on the casing stem portion

Tower saddle Steel Structure and Casting T1-1: JSW Mr. Kon, Mr. Nagaya, CWI Mr. Kuan and Caltrans QAI met at JSW welding shop to discuss the T1-1 tower saddle which was found an open gap of 3mm which exceeded the tolerance of Caltrans approved drawing (within 1mm). It happened late night during fit up the base portion and casting portion together. The open gap is caused by over machining. The discussion resulted in JSW use buttering welding method build up to 3mm height and 40mm width from center of stem casting portion. Next, the build up weldment would be ground to a suitable fit up bevel after welding. Then, Magnetic Particle Test (MT) and

Ultrasonic Testing (UT) will performed to assure free defect on build up portion. Caltrans Informed to JSW Mr. Kon that build up weldment is major repair for welding, he has to file RFI to Caltrans for approval and QAI will refer this information to SMR Nina Choy and Mr. Jay Dorst.

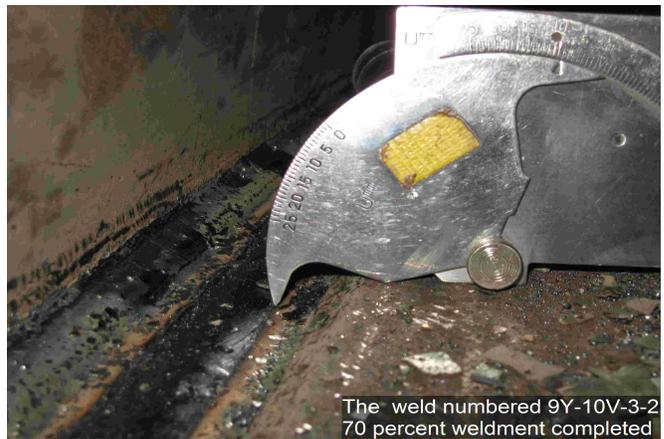
The weld numbered 9Y-10V-3-2
70 percent weldment completed

Tower Saddle Steel Structure T1-3: Caltrans Quality Assurance Inspector (QAI) representative Mr. Wai Pau, traveled to Japan Steel Works (JSW) Muroran plant to observe one welder performed Flux Cored Arc Welding (FCAW) process on a rib #9-10 of T1-3 tower saddle steel structure. The weld numbered 9Y-10V-3-2. The material used for grillage was reported by CWI Mr. Chung Kuan as ASTM 709 Gr-345 plate having a thickness measurement of 120mm. The weld joint design used butt joint, double-V groove partial joint penetration groove weld (PJP). The filler metal and shield gas used for FCAW welding is Hoballoy wire TM-95K2, 1.6 diameter with 100% CO₂ made by Hobart Brothers, USA. The parameters used for FCAW welding of assemblies were conducted in accordance with Caltrans approved WPS #SJ-3012-3. The FCAW welding process and parameters have been monitored and recorded by CWI inspectors Mr. Chung Kuan. Based on Caltrans QA observation, the FCAW welding operation appeared to be in general compliance with requirements of AWS D1.5 2002 and Caltrans contract documents. The welder completed 70 % welding on weld 9Y-10V-3-2 and waited for the tower saddle to be turned to the other side and continue welding. This welding sequence procedure is for prevention of distortion during welding. The turning operation will take four hours to complete.
