Quality Assurance and Source Inspection

Contract #: 04-0120F4Cty: SF/ALA Rte: 80 PM: 13.2/13.9File #: 70.28**WELDING INSPECTION REPORT****Resident Engineer:** Pursell, Gary**Address:** 333 Burma Road**City:** Oakland, CA 94607**Report No:** WIR-005162**Date Inspected:** 09-Jan-2009**Project Name:** SAS Superstructure**OSM Arrival Time:** 830**Prime Contractor:** American Bridge/Fluor Enterprises, a JV**OSM Departure Time:** 1930**Contractor:** Japan Steel Works**Location:** Muroran, Japan**CWI Name:** Chung Kuan**CWI Present:** Yes No**Inspected CWI report:** Yes No N/A**Rod Oven in Use:** Yes No N/A**Electrode to specification:** Yes No N/A**Weld Procedures Followed:** Yes No N/A**Qualified Welders:** Yes No N/A**Verified Joint Fit-up:** Yes No N/A**Approved Drawings:** Yes No N/A**Approved WPS:** Yes No N/A**Delayed / Cancelled:** Yes No N/A**Bridge No:** 34-0006**Component:** Tower, Jacking and Deviation Saddles**Summary of Items Observed:**

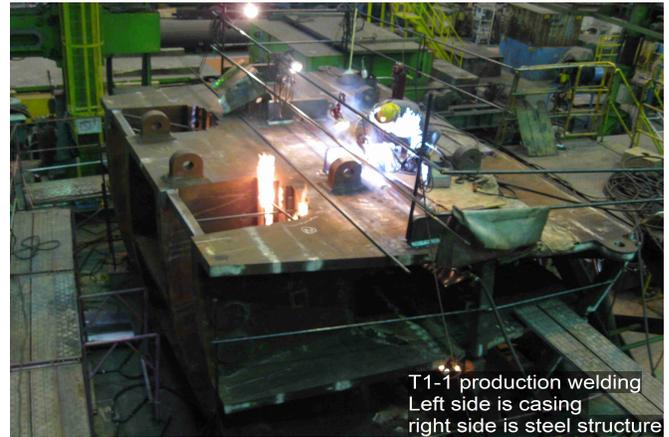
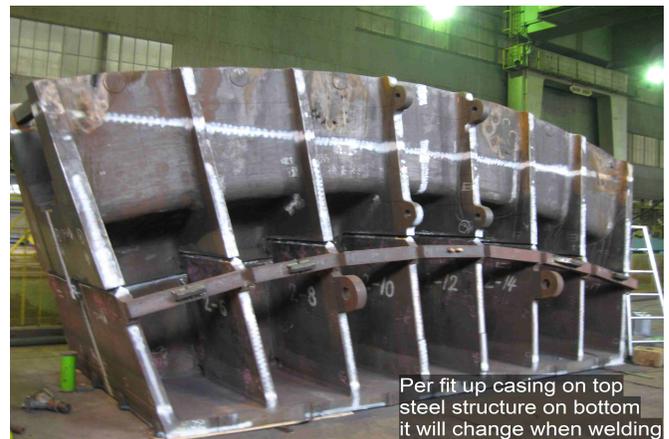
T1-1 Tower Saddle Casting and Steel Structure joint section: Caltrans Quality Assurance Inspector (QAI) representative observed three Japan Steel Works (JSW) welders perform Flux Cored Arc Welding (FCAW) process on rib plate welds 7S-5U-1, 7S-5U-2 and 7S-5U-3 of T1-1 tower. These three welds are connecting the casting and steel structure. The three welders started welding from after root pass to 70% weld metal complete. The filler metal used for FCAW is Hoballoy wire TM-55, 1.6 diameter made by Hobart Brothers, USA. The parameters used for FCAW welding of assemblies were conducted in accordance with Caltrans approved WPS #SJ-3011-6. The FCAW welding process and parameters have been monitored and recorded by CWI inspector Mr. Chung Kuan. Based on Caltrans QA observation, the FCAW welding operation appeared to be in general compliance with requirements of AWS D1.5 2002 and Caltrans contract documents.

W2E2 West Deviation Saddle Casting and Steel Structure joint section: Caltrans QA Inspector representative observed two JSW welders perform fit up of the W2E2 west deviation saddle casting and steel structure joint section. The gap and alignment of rib plates and stem plates appear to meet the requirement of approved drawing. The JSW Welding Engineer Mr. Nagaya informed Caltrans QA Inspector that joint section will move to welding station for permanent fit up and production welding next week. Based on Caltrans observation, no discrepancies were noted.

W2E3 and W2W3 West Deviation Saddle castings: Caltrans QAI observed two JSW workers performed grinding process on exterior rough surface of rib sides for W2E3 and W2W3 west deviation saddles after arc-gouging.

Grinding process is to remove all the excess metal, oxide film and slag caused by gouging. The purpose for grinding is prepared for NDT testing. Base on Caltrans observation, no discrepancies were noted.
