DEPARTMENT OF TRANSPORTATION

Quality Assurance and Source Inspection

Contract #: 04-0120F4Cty: SF/ALA Rte: 80 PM: 13.2/13.9File #: 69.28**WELDING INSPECTION REPORT****Resident Engineer:** Pursell, Gary**Address:** 333 Burma Road**City:** Oakland, CA 94607**Report No:** WIR-005393**Date Inspected:** 31-Jan-2009**Project Name:** SAS Superstructure**OSM Arrival Time:** 645**Prime Contractor:** American Bridge/Fluor Enterprises, a JV**OSM Departure Time:** 1845**Contractor:** Zhenhua Port Machinery Company, Ltd (ZPMC), Changxing Island **Location:** Shanghai, China**CWI Name:** See Below**CWI Present:** Yes No**Inspected CWI report:** Yes No N/A**Rod Oven in Use:** Yes No N/A**Electrode to specification:** Yes No N/A**Weld Procedures Followed:** Yes No N/A**Qualified Welders:** Yes No N/A**Verified Joint Fit-up:** Yes No N/A**Approved Drawings:** Yes No N/A**Approved WPS:** Yes No N/A**Delayed / Cancelled:** Yes No N/A**Bridge No:** 34-0006**Component:** OBG Fabrication**Summary of Items Observed:**

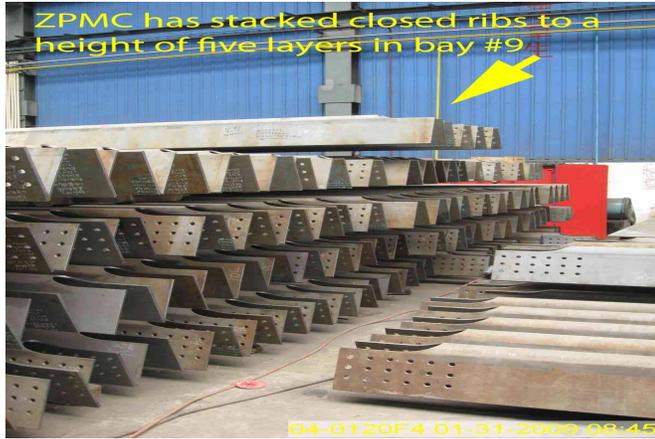
This QA Inspector observed ZPMC has staged closed ribs in the east end of OBG Bay 9 to a height of five layers. ZPMC drawing FP-4 states "The storage of U-Ribs shall not exceed 4 layers". The QA Inspector informed ZPMC QC CWI Mr. Sun Bo that ZPMC has improperly staged closed rib and Mr. Bo said he will have ZPMC remove the top layer of improperly staged closed ribs. Later in the shift the QA Inspector observed ZPMC has removed the improperly staged closed ribs. On January 14 a similar problem was observed and after QC was informed the improperly staged U-Ribs were removed from the fifth layer of staged U-Ribs. See below for a photograph showing where ZPMC has stacked closed ribs in the east end of OBG Bay 9 to a height of five layers.
