Quality Assurance and Source Inspection

Contract #: 04-0120F4Cty: SF/ALA Rte: 80 PM: 13.2/13.9File #: 13.28**WELDING INSPECTION REPORT****Resident Engineer:** Pursell, Gary**Address:** 333 Burma Road**City:** Oakland, CA 94607**Report No:** WIR-005815**Date Inspected:** 20-Mar-2009**Project Name:** SAS Superstructure**OSM Arrival Time:** 630**Prime Contractor:** American Bridge/Fluor Enterprises, a JV**OSM Departure Time:** 1600**Contractor:** Oregon Iron Works Clackamas, Or.**Location:** Clackamas, Oregon**CWI Name:** See below**CWI Present:** Yes No**Inspected CWI report:** Yes No N/A**Rod Oven in Use:** Yes No N/A**Electrode to specification:** Yes No N/A**Weld Procedures Followed:** Yes No N/A**Qualified Welders:** Yes No N/A**Verified Joint Fit-up:** Yes No N/A**Approved Drawings:** Yes No N/A**Approved WPS:** Yes No N/A**Delayed / Cancelled:** Yes No N/A**Bridge No:** 34-0006**Component:** Hinge K Pipe Beams**Summary of Items Observed:**

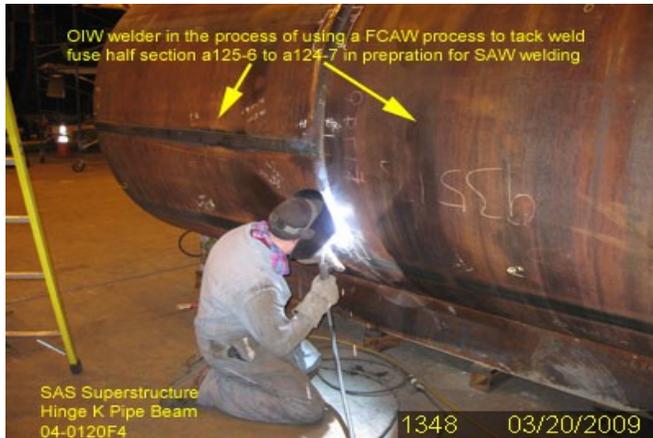
QA Inspector Brannon randomly observed OIW qualified welder Mr. Rick Hinkle ID#H49 tack welding joining half fuse section MK#a124-7 (HPS485 W) to half fuse section MK#a124-6 (HPS485 W). The complete joint penetration (CJP) weld is identified as weld joint #WM3-18. Mr. Hinkle was observed welding in the 1G (flat) and 3G (vertical) positions utilizing flux corded arc welding (FCAW) process with a .045 inch (1.2mm) diameter electrode, filler metal brand Hobart Fabco 91K2-C class 91T1-K2J semi-automatic.

QA Inspector Brannon randomly observed OIW qualified welder Mr. Craig Jacobson ID#J6 setting up and preheating to start welding forging MK#a111-1 (A508 Gr. 4N Class 2) to base plate MK#a110 (HPS 485 W).

The following digital photograph below illustrates observation of the activities being performed.
