DEPARTMENT OF TRANSPORTATION

Quality Assurance and Source Inspection

Contract #: 04-0120F4Cty: SF/ALA Rte: 80 PM: 13.2/13.9File #: 69.28**WELDING INSPECTION REPORT****Resident Engineer:** Pursell, Gary**Address:** 333 Burma Road**City:** Oakland, CA 94607**Report No:** WIR-006078**Date Inspected:** 19-Feb-2009**Project Name:** SAS Superstructure**OSM Arrival Time:** 645**Prime Contractor:** American Bridge/Fluor Enterprises, a JV**OSM Departure Time:** 1845**Contractor:** Zhenhua Port Machinery Company, Ltd (ZPMC), Changxing Island **Location:** Shanghai, China**CWI Name:** See Below**CWI Present:** Yes No**Inspected CWI report:** Yes No N/A**Rod Oven in Use:** Yes No N/A**Electrode to specification:** Yes No N/A**Weld Procedures Followed:** Yes No N/A**Qualified Welders:** Yes No N/A**Verified Joint Fit-up:** Yes No N/A**Approved Drawings:** Yes No N/A**Approved WPS:** Yes No N/A**Delayed / Cancelled:** Yes No N/A**Bridge No:** 34-0006**Component:** OBG Fabrication**Summary of Items Observed:**

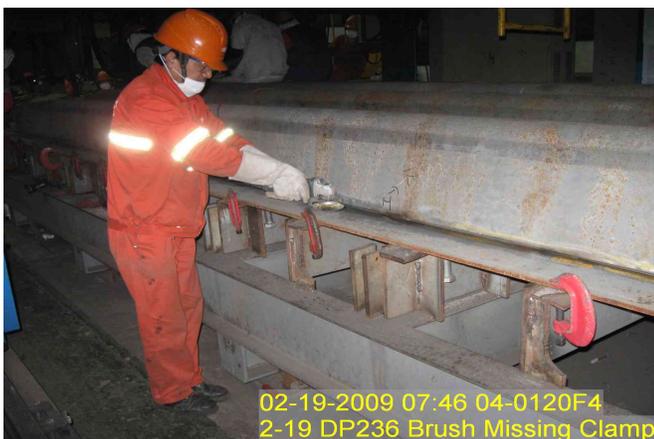
The QA Inspector monitored welding of closed rib of deck plate DP236-001 using gantry #1. The QA Inspector observed four ZPMC welders preparing to use welding procedure specification WPS-B-T-2342-U1(Urib)-4 using the gas metal arc welding process for the root pass of six partial penetration groove welds on closed rib welds at the same time. The QA Inspector observed ZPMC personnel using torches to preheat the base material where the welds are going to be made. The QA Inspector observed several of the "C" clamps are not attached to the sides of the deck plate and the weld grooves appear to have a light layer of rust and the QA Inspector asked ABF representative Ms. Lu Yun if she has observed the missing "C" clamps and light rust and Ms. Lu Yun had ZPMC install additional "C" clamps and wire brush the entire weld joint prior to commencement of welding. See the photograph below for additional information. ZPMC has multiple welding manipulators attached to a movable gantry that runs on a track along the length of the stiffener plates. ZPMC QC and ABF representatives were both monitoring this welding. The QA Inspector observed QC had documented a welding travel speed of 536 mm per minute for the root passes. As the welding commences, each of the welders is responsible for one of the welding heads. Welder Ms. Wang Xiao Rong, stencil 59445 completed the root pass of weld #1 with a welding current of approximately 365 amps and 30.7 volts. Welder Mr. Tiang Shuang Chen, stencil 201788 completed the root pass of weld #2 with a welding current of approximately 375 amps and 31.1 volts. Welder Xhang Shao Hui stencil 59403 completed the root pass of weld #5 with a welding current of approximately 370 amps and 30.8 volts. Welder Mr. Chen Jie, stencil 59468 completed the root pass of weld #6 with a welding current of approximately 360 amps and 31.5 volts. Welder Ms. Zhang Li Ping, stencil 201840 completed the root pass of weld #9 with a welding current of approximately 370 amps and 31.2 volts. Welder Mr. Zhao Cheng Shuang, stencil 59400 completed the root pass of weld #10 with a welding current of approximately 370 amps and 31.0 volts. Items observed by this QA Inspector appear to comply with project specifications.
