Quality Assurance and Source Inspection

Contract #: 04-0120F4Cty: SF/ALA Rte: 80 PM: 13.2/13.9File #: 69.28**WELDING INSPECTION REPORT****Resident Engineer:** Pursell, Gary**Address:** 333 Burma Road**City:** Oakland, CA 94607**Report No:** WIR-006101**Date Inspected:** 18-Mar-2009**Project Name:** SAS Superstructure**OSM Arrival Time:** 645**Prime Contractor:** American Bridge/Fluor Enterprises, a JV**OSM Departure Time:** 1845**Contractor:** Zhenhua Port Machinery Company, Ltd (ZPMC), Changxing Island **Location:** Shanghai, China**CWI Name:** See Below**CWI Present:** Yes No**Inspected CWI report:** Yes No N/A**Rod Oven in Use:** Yes No N/A**Electrode to specification:** Yes No N/A**Weld Procedures Followed:** Yes No N/A**Qualified Welders:** Yes No N/A**Verified Joint Fit-up:** Yes No N/A**Approved Drawings:** Yes No N/A**Approved WPS:** Yes No N/A**Delayed / Cancelled:** Yes No N/A**Bridge No:** 34-0006**Component:** Tower Fabrication**Summary of Items Observed:**

Tower Bay 10

Tower Bay 11

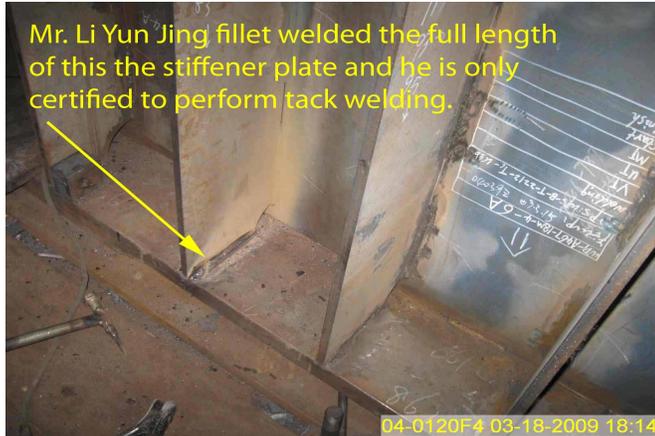
The QA Inspector observed ZPMC welder Mr. Li Yun Jing, stencil 040392 is using the shielded metal arc process to fillet tack weld stiffener plates to shear link WDI-A467-18M-4. The QA Inspector observed ZPMC CWI Mr. Wu Ming Kai monitoring this welding. The QA Inspector observed Mr. Li Yun Jing had fillet welded the full length of the bottom of one of the stiffener plates and since Mr. Li Yun Jing is only qualified to tack weld Mr. Li Yun Jing was not certified to make this weld. The QA Inspector informed Mr. Wu Ming Kai that the full length fillet weld that had been made by Mr. Li Yun Jing is in violation of the AWS D1.5 Welding Code. Mr. Wu Ming Kai said he will have Mr. Li Yun Jing remove the fillet weld with a grinder. Items observed by the QA Inspector do not appear to fully comply with project specifications. See the photograph below for additional information.
