DEPARTMENT OF TRANSPORTATION

Quality Assurance and Source Inspection

Contract #: 04-0120F4Cty: SF/ALA Rte: 80 PM: 13.2/13.9File #: 13.28**WELDING INSPECTION REPORT****Resident Engineer:** Pursell, Gary**Address:** 333 Burma Road**City:** Oakland, CA 94607**Report No:** WIR-006139**Date Inspected:** 08-Apr-2009**Project Name:** SAS Superstructure**OSM Arrival Time:** 700**Prime Contractor:** American Bridge/Fluor Enterprises, a JV**OSM Departure Time:** 1530**Contractor:** Oregon Iron Works Clackamas, Or.**Location:** Clackamas, OR**CWI Name:** Mike Gregson, Rob Walters**CWI Present:** Yes No**Inspected CWI report:** Yes No N/A**Rod Oven in Use:** Yes No N/A**Electrode to specification:** Yes No N/A**Weld Procedures Followed:** Yes No N/A**Qualified Welders:** Yes No N/A**Verified Joint Fit-up:** Yes No N/A**Approved Drawings:** Yes No N/A**Approved WPS:** Yes No N/A**Delayed / Cancelled:** Yes No N/A**Bridge No:** 34-0006**Component:** Hinge K Pipe Beams**Summary of Items Observed:**

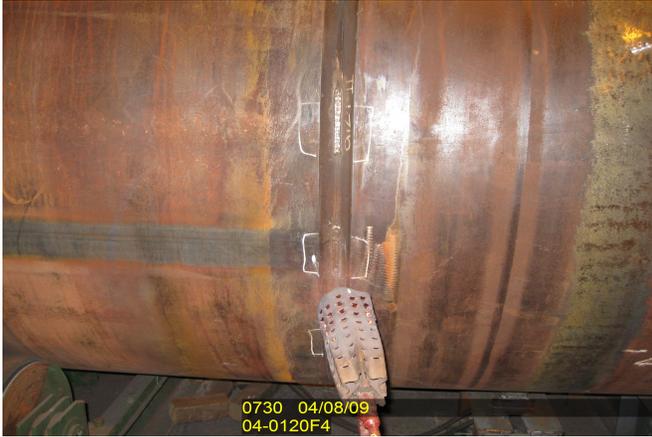
QA Inspector randomly witnessed OIW welder #J6, Mr. Craig Jacobsen perform backgouge on completed submerged arc welding (SAW) root pass, joint designated as CJP (AWS D1.5 TC-U9a-S). As shown in picture below.....

QA Inspector noticed that this weld joint was a pipe beam base plate, piece mark identified as a110-4 to pipe forging, identified as piece mark a111-4.

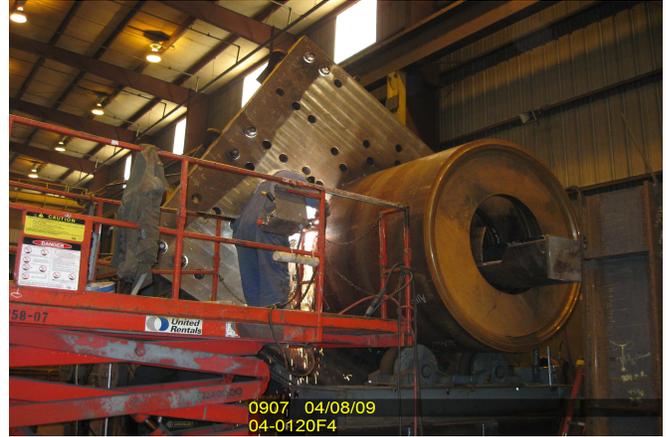
QA Inspector randomly witnessed welder #S53, Mr. Jerry Shepherd, perform pre-heating on half fuse pipe sub-assembly, piece mark identified as a124-3 to half fuse pipe sub-assembly, piece mark identified as a124-11, as shown in picture below.....

QA Inspector noticed this butt weld joint was designated as a complete joint penetration (CJP AWS D1.5 B-U3c-S) and had been previously tack welded by Mr. Shepherd, as shown in picture below.....
