Contract #: 04-0120F4Cty: SF/ALA Rte: 80 PM: 13.2/13.9File #: 13.28**WELDING INSPECTION REPORT****Resident Engineer:** Pursell, Gary**Address:** 333 Burma Road**City:** Oakland, CA 94607**Report No:** WIR-006206**Date Inspected:** 13-Apr-2009**Project Name:** SAS Superstructure**OSM Arrival Time:** 700**Prime Contractor:** American Bridge/Fluor Enterprises, a JV**OSM Departure Time:** 1530**Contractor:** Oregon Iron Works Clackamas, Or.**Location:** Clackamas, OR**CWI Name:** Mike Gregson, Rob Walters**CWI Present:** Yes No**Inspected CWI report:** Yes No N/A**Rod Oven in Use:** Yes No N/A**Electrode to specification:** Yes No N/A**Weld Procedures Followed:** Yes No N/A**Qualified Welders:** Yes No N/A**Verified Joint Fit-up:** Yes No N/A**Approved Drawings:** Yes No N/A**Approved WPS:** Yes No N/A**Delayed / Cancelled:** Yes No N/A**Bridge No:** 34-0006**Component:** Hinge K Pipe Beams**Summary of Items Observed:**

WELDING INSPECTION REPORT

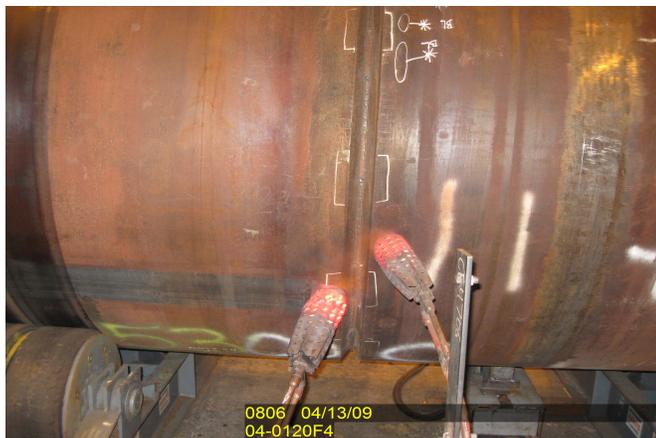
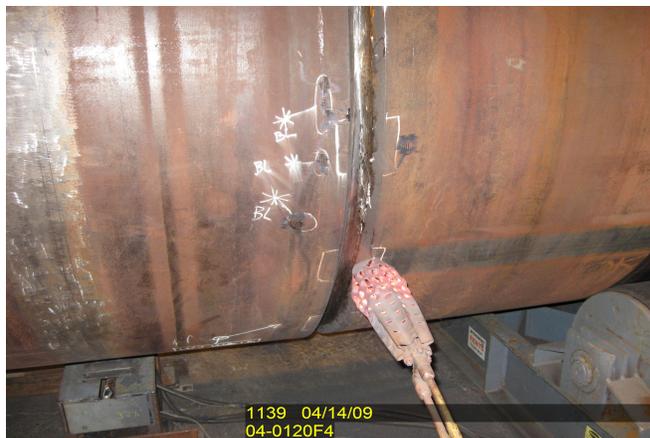
QA Inspector randomly witnessed welder #S53, Mr. Jerry Shepherd, perform submerged arc welding (SAW) on CJP (AWS D1.5 B-U3c-S), half fuse pipe assembly, (piece mark identified as a124-3), to half fuse pipe assembly, (piece mark identified as a124-11), in the flat position (1G).

QA Inspector verified Mr. Jerry Shepherd was currently qualified for this welding process/position and performed a random pre-heat check and recorded temperatures of approximately 375 degrees Fahrenheit, which is in compliance with the OIW welding procedure specification (WPS 4020). See pre-heating pictures below.....
