Contract #: 04-0120F4Cty: SF/ALA Rte: 80 PM: 13.2/13.9File #: 13.28**WELDING INSPECTION REPORT****Resident Engineer:** Pursell, Gary**Address:** 333 Burma Road**City:** Oakland, CA 94607**Report No:** WIR-006413**Date Inspected:** 27-Apr-2009**Project Name:** SAS Superstructure**OSM Arrival Time:** 700**Prime Contractor:** American Bridge/Fluor Enterprises, a JV**OSM Departure Time:** 1530**Contractor:** Oregon Iron Works Clackamas, Or.**Location:** Clackamas, OR**CWI Name:** Mike Gregson, Rob Walters**CWI Present:** Yes No**Inspected CWI report:** Yes No N/A**Rod Oven in Use:** Yes No N/A**Electrode to specification:** Yes No N/A**Weld Procedures Followed:** Yes No N/A**Qualified Welders:** Yes No N/A**Verified Joint Fit-up:** Yes No N/A**Approved Drawings:** Yes No N/A**Approved WPS:** Yes No N/A**Delayed / Cancelled:** Yes No N/A**Bridge No:** 34-0006**Component:** Hinge K Pipe Beams**Summary of Items Observed:**

Hinge-K Pipe Beam Assembly 102A-1: 4/27/09

Hinge-K Pipe Beam Fuse Assembly 120A-1: 4/27/09

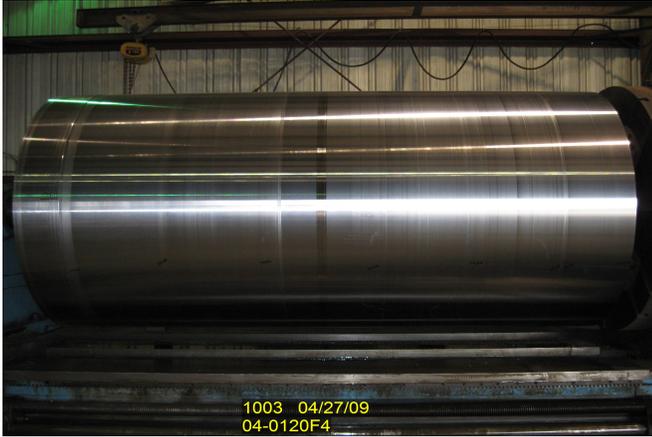
QA Inspector noticed that A & G Machining had completed the third and final pass of .160" (4mm) and had recorded final random dimensional measurements. QA Inspector noticed that A&G Machining had measured the circumference of this fuse assembly 120A-1 and recorded the final outside diameter measurements, as shown below.

QA Inspector noticed that OIW QC Manager Tom Tomovick and project manager Bill Pender were previously present at A&G Machining, to verify these dimensional checks were in compliance with the contract requirements of 1900mm (+/- 3mm), final outside diameter.

QA Inspector spoke with A&G Machining and A&G explained this fuse assembly 120A-1 would be brought back to OIW fabrication shop on Thursday (4/30/09), for preparation of the stainless steel overlay welding process. See picture below of completed fuse assembly.....
