Quality Assurance and Source Inspection

Contract #: 04-0120F4Cty: SF/ALA Rte: 80 PM: 13.2/13.9File #: 69.28**WELDING INSPECTION REPORT****Resident Engineer:** Pursell, Gary**Address:** 333 Burma Road**City:** Oakland, CA 94607**Report No:** WIR-006433**Date Inspected:** 23-Apr-2009**Project Name:** SAS Superstructure**OSM Arrival Time:** 700**Prime Contractor:** American Bridge/Fluor Enterprises, a JV**OSM Departure Time:** 1900**Contractor:** Zhenhua Port Machinery Company, Ltd (ZPMC), Changxing Island **Location:** Shanghai, China**CWI Name:** Chen Xi**CWI Present:** Yes No**Inspected CWI report:** Yes No N/A**Rod Oven in Use:** Yes No N/A**Electrode to specification:** Yes No N/A**Weld Procedures Followed:** Yes No N/A**Qualified Welders:** Yes No N/A**Verified Joint Fit-up:** Yes No N/A**Approved Drawings:** Yes No N/A**Approved WPS:** Yes No N/A**Delayed / Cancelled:** Yes No N/A**Bridge No:** 34-0006**Component:** crossbeams**Summary of Items Observed:**

OBG cross beam CB1

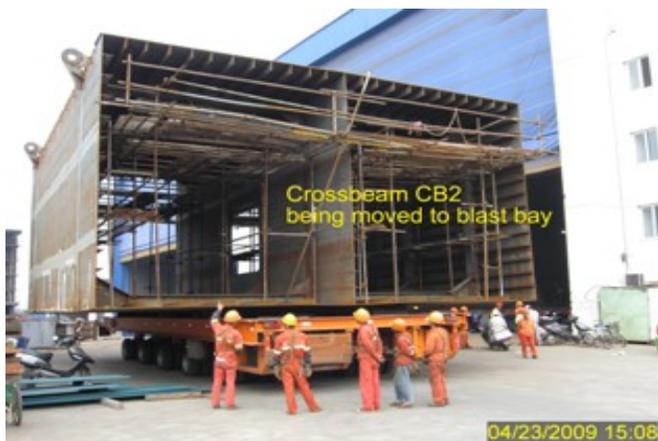
This QA observed ZPMC personnel fitting and tack welding the bottom panel to the cross beam side panels. QA observed ZPMC QC CWI perform in process weld joint inspection. No other significant work was observed on this cross beam during the time QA was present.
