DEPARTMENT OF TRANSPORTATION

Contract #: 04-0120F4Cty: SF/ALA Rte: 80 PM: 13.2/13.9File #: 69.28**WELDING INSPECTION REPORT****Resident Engineer:** Pursell, Gary**Address:** 333 Burma Road**City:** Oakland, CA 94607**Report No:** WIR-006435**Date Inspected:** 26-Apr-2009**Project Name:** SAS Superstructure**OSM Arrival Time:** 700**Prime Contractor:** American Bridge/Fluor Enterprises, a JV**OSM Departure Time:** 1900**Contractor:** Zhenhua Port Machinery Company, Ltd (ZPMC), Changxing Island **Location:** Shanghai, China**CWI Name:** Chen Xi / Li Yang**CWI Present:** Yes No**Inspected CWI report:** Yes No N/A**Rod Oven in Use:** Yes No N/A**Electrode to specification:** Yes No N/A**Weld Procedures Followed:** Yes No N/A**Qualified Welders:** Yes No N/A**Verified Joint Fit-up:** Yes No N/A**Approved Drawings:** Yes No N/A**Approved WPS:** Yes No N/A**Delayed / Cancelled:** Yes No N/A**Bridge No:** 34-0006**Component:** crossbeams and superstructure assembly**Summary of Items Observed:**

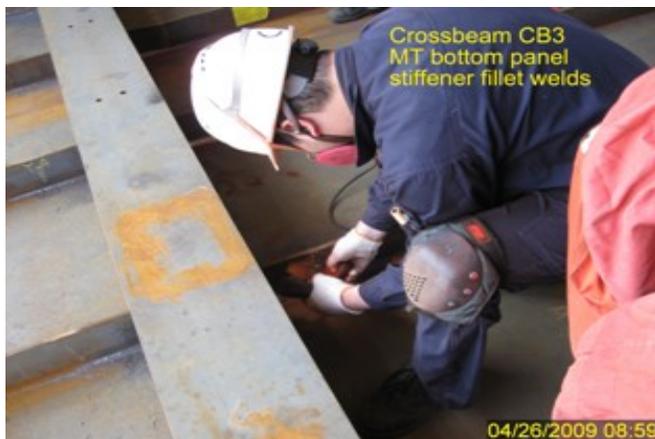
This QA observed ZPMC personnel perform various functions relative to the fabrication and assembly of the OBG superstructure assembly including the following: Install permanent bolts in OBG segment 2BE at the floorbeam diagonal bracing connections to the upper and lower floorbeam sections. Prepare ends of bottom panel T-stiffeners for splicing segment 2BE to 3AE. Install and match drill deck panel u-rib splice plates at 4AE to 4BE splice.
