**DEPARTMENT OF TRANSPORTATION**

Contract #: 04-0120F4Cty: SF/ALA Rte: 80 PM: 13.2/13.9File #: 69.28**WELDING INSPECTION REPORT****Resident Engineer:** Pursell, Gary**Address:** 333 Burma Road**City:** Oakland, CA 94607**Report No:** WIR-006437**Date Inspected:** 28-Apr-2009**Project Name:** SAS Superstructure**OSM Arrival Time:** 700**Prime Contractor:** American Bridge/Fluor Enterprises, a JV**OSM Departure Time:** 1900**Contractor:** Zhenhua Port Machinery Company, Ltd (ZPMC), Changxing Island **Location:** Shanghai, China**CWI Name:** Huang Wen Pang**CWI Present:** Yes No**Inspected CWI report:** Yes No N/A**Rod Oven in Use:** Yes No N/A**Electrode to specification:** Yes No N/A**Weld Procedures Followed:** Yes No N/A**Qualified Welders:** Yes No N/A**Verified Joint Fit-up:** Yes No N/A**Approved Drawings:** Yes No N/A**Approved WPS:** Yes No N/A**Delayed / Cancelled:** Yes No N/A**Bridge No:** 34-0006**Component:** crossbeams**Summary of Items Observed:**

## WELDING INSPECTION REPORT

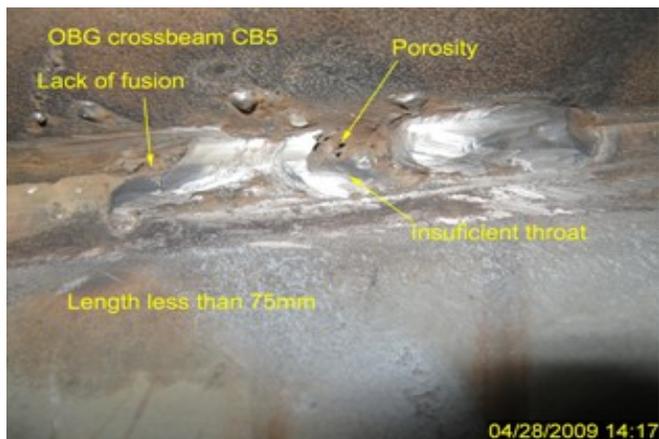
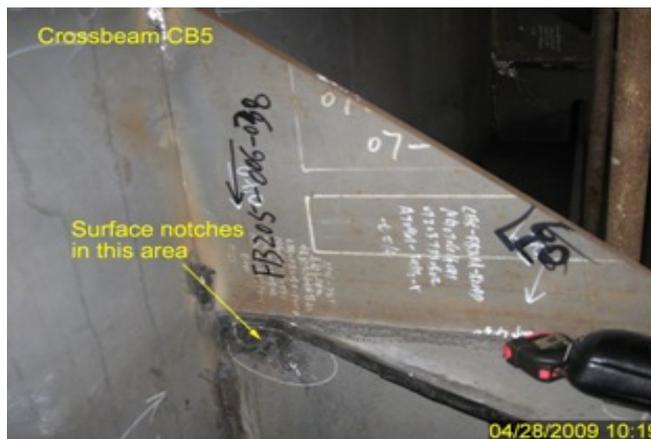
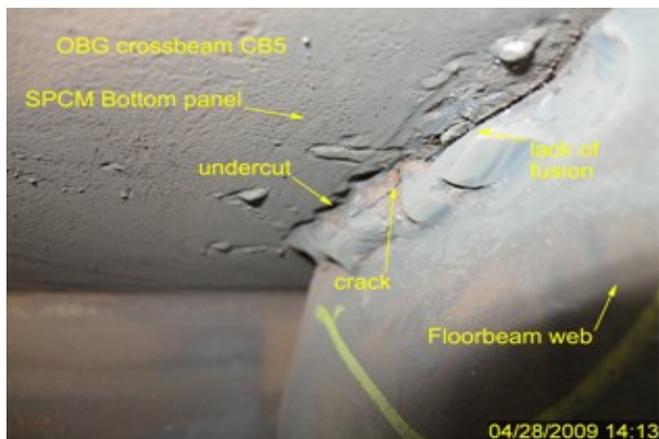
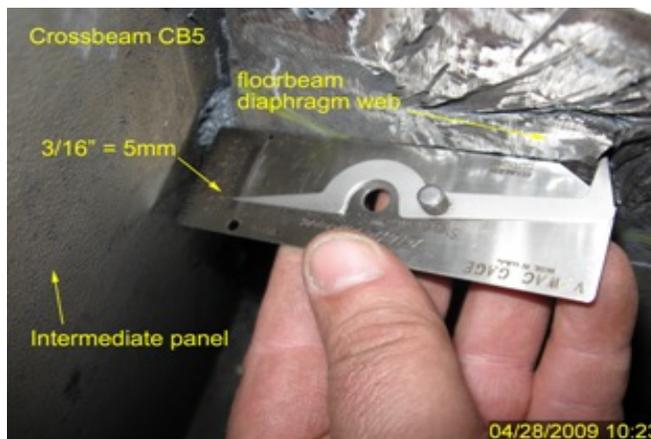
During random in process visual inspection of above mentioned cross beam, this QA observed numerous Fracture Critical Weld (FCW) tack welds that do not appear to comply with the contract documents. The tack welds in question are joining the floorbeam diaphragms to the SPCM areas of the side and bottom panels. The length of these tack welds measure 30mm to 50mm and exhibit various non-compliant visual discontinuities. AWS D1.5 2002 section 12, table 12.2 specifies tack welds shall be a minimum of 75mm in length. AWS D1.5 2002 section 3, paragraph 3.3.7.1 states "tack welds shall be subject to the same quality requirements as the finished welds". The contractors QC CWI identified as Mr. Huang Wen Pang and ZPMC QC engineer identified as Mr. Guo Yuan Ting re-inspected the tack welds and concurred with this QA's findings. This QA informed the contractors QC CWI identified as Mr. Huang Wen Pang and ABF QA inspector identified as Mr. Kelvin Cheung of this issue and informed both parties that an incident report would be forth coming.

During random in process visual inspection of above mentioned cross beam, this QA observed base metal surface notches on floorbeam diaphragm web plates. These notches appear to have been created when ZPMC personnel removed both of the flange wings, as specified on the drawings, using a hand operated oxy/fuel torch. These notches measure 3mm to 5mm in depth. This condition exists on both sides of the web plate on 3 of the 4 floorbeam diaphragms in this crossbeam. ZPMC QC and ABF QC were aware of this issue and have informed this QA that ZPMC intends to repair the notches as soon as The contractors technology department issues a procedure to do so. See attached photos.
