Contract #: 04-0120F4Cty: SF/ALA Rte: 80 PM: 13.2/13.9File #: 69.28**WELDING INSPECTION REPORT****Resident Engineer:** Pursell, Gary**Address:** 333 Burma Road**City:** Oakland, CA 94607**Report No:** WIR-006471**Date Inspected:** 26-Apr-2009**Project Name:** SAS Superstructure**OSM Arrival Time:** 1845**Prime Contractor:** American Bridge/Fluor Enterprises, a JV**OSM Departure Time:** 645**Contractor:** Zhenhua Port Machinery Company, Ltd (ZPMC), Changxing Island **Location:** Shanghai, China**CWI Name:** See Below**CWI Present:** Yes No**Inspected CWI report:** Yes No N/A**Rod Oven in Use:** Yes No N/A**Electrode to specification:** Yes No N/A**Weld Procedures Followed:** Yes No N/A**Qualified Welders:** Yes No N/A**Verified Joint Fit-up:** Yes No N/A**Approved Drawings:** Yes No N/A**Approved WPS:** Yes No N/A**Delayed / Cancelled:** Yes No N/A**Bridge No:** 34-0006**Component:** OBG and Tower Fabrication**Summary of Items Observed:**

WELDING INSPECTION REPORT

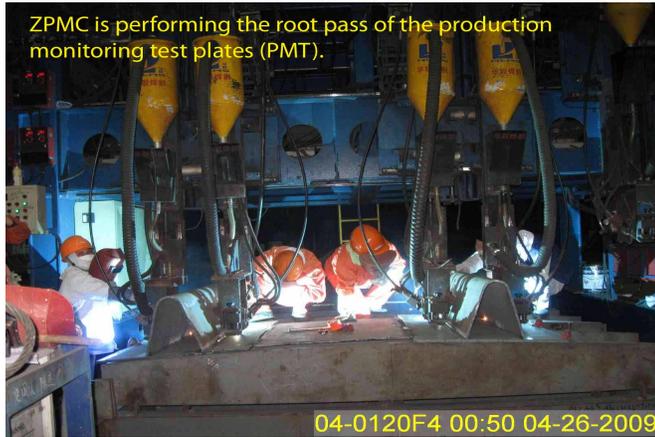
The QA Inspector monitored welding of closed rib Production Monitoring Test (PMT) representing deck plates DP510-001 and DP295-001 which were welded using one single base plate at around 0019 hours using gantry #1. The QA Inspector observed four ZPMC welders using welding procedure specification WPS-B-T-2342-U1(Urib)-4 using the gas metal arc welding process for the root pass and submerged arc welding process for the cover pass of partial penetration groove welds on four PMT closed rib welds at the same time. ZPMC has multiple welding manipulators attached to a movable gantry that runs on a track along the length of the stiffener plates. The QA Inspector observed a welding travel speed of approximately 534 mm per minute for the root passes and 515 mm per minute for the cover passes. As the welding commences, each of the welders is responsible for one of the welding heads. Welder Mr. Xiang Huan Feng, stencil 59416 completed the root pass of weld #1 with a welding current of approximately 370 amps and 31.2 volts and the cover pass welding current of approximately 685 amps and 25.0 volts. Welder Mr. Xhang Shao Hui stencil 59403 completed the root pass of weld #2 with a welding current of approximately 370 amps and 31.4 volts and the cover pass welding current of approximately 680 amps and 25.3 volts. Welder Mr. Xing Jie, stencil 59378 completed the root pass of weld #3 with a welding current of approximately 360 amps and 31.2 volts and the cover pass welding current of approximately 690 amps and 25.0 volts. Welder Mr. Jiang Ting Quang, stencil 062265 completed the root pass of weld #4 with a welding current of approximately 370 amps and 31.3 volts and the cover pass welding current of approximately 685 amps and 25.3 volts.

The QA Inspector performed random visual inspection of the root passes and cover passes and items observed appear to comply with project specifications. Following completion of the welding ZPMC QC CWI Inspector Mr. Sun Bo marked a 500 mm length on each of the welds as being the areas that are to be representative of this PMT test. The QA Inspector observed ZPMC NDE Inspector Mr. Jihong performing ultrasonic of each of the six welds in the areas where Mr. Bo had marked for PMT testing. Following ZPMC's UT acceptance the QA Inspector marked a total of 15 locations where macroetch samples are to be obtained. ZPMC then cut and prepared macroetch samples. ZPMC QC CWI Inspector Mr. Sun Bo and ABF representative Mr. Cao Haizhou visually inspected these macroetch samples and documented their acceptance on the ZPMC Production Monitoring Test Plate Inspection Report sheet dated April 27, 2009. The QA Inspector visually inspected each of these macroetch samples and items observed by the QA Inspector appear to comply with project specifications and the QA

Inspector documented this inspection on the bottom of the “Production Monitoring Test Plate Inspection Report”. See the photograph below for additional information.
