Contract #: 04-0120F4Cty: SF/ALA Rte: 80 PM: 13.2/13.9File #: 13.28**WELDING INSPECTION REPORT****Resident Engineer:** Pursell, Gary**Address:** 333 Burma Road**City:** Oakland, CA 94607**Report No:** WIR-006549**Date Inspected:** 01-May-2009**Project Name:** SAS Superstructure**OSM Arrival Time:** 1400**Prime Contractor:** American Bridge/Fluor Enterprises, a JV**OSM Departure Time:** 2230**Contractor:** Oregon Iron Works Clackamas, Or.**Location:** Clackamas, OR

Summary of Items Observed: On this date, Caltrans Quality Assurance Inspector (QA) Clete Henke was present at Oregon Iron Works, Inc. (OIW) in Clackamas, OR for observation of fabrication of the Hinge K Pipe Beams and related activities including in process welding and OIW Quality Control (QC) visual and nondestructive testing. The following observations were recorded:

Hinge-K Pipe Beam Fuse Sub-Assembly 120A-5:

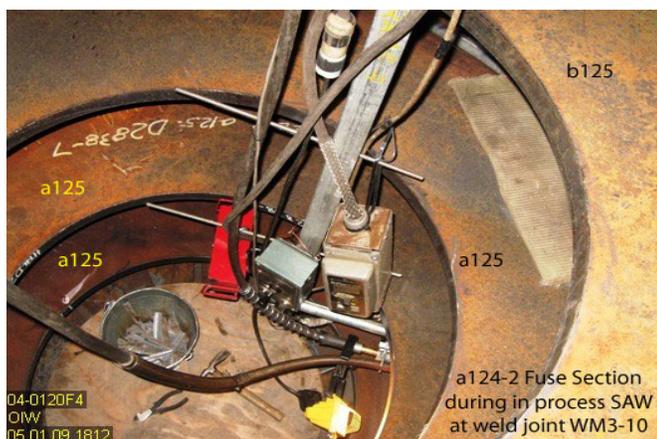
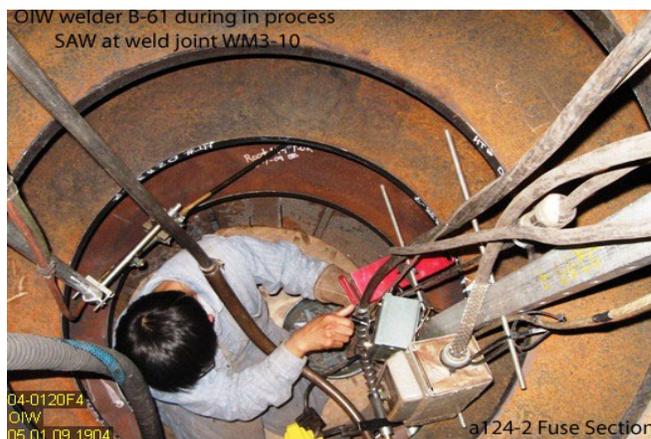
The QA Inspector intermittently monitored OIW welder Bounheune Savanh (WID S74) during in progress Submerged Arc Welding (SAW) at weld joint WM3-10 joining a125 stiffener ring to a124-2 Fuse Section. The QA Inspector observed as OIW QC Inspector Steve Barnett performed Magnetic particle Testing (MT) and Visual Inspection (VT) of completed root passes at weld WM3-10. Mr. Barnett stated that he had located no rejectable indications. The QA Inspector subsequently performed 100% VT at the location noted above finding the root passes to be in general compliance with contract documents. The QA Inspector intermittently observed as welder S74 continued to deposit SAW fill and cover passes in the flat (1G) position in accordance with approved welding procedure 4020. The QA Inspector noted the OIW welder was maintaining continuous preheat utilizing two torches. An OIW helper was observed assisting welder S74 during SAW process. The QA Inspector observed OIW QC Inspector Steve Barnett regularly monitoring and recording the in process SAW parameters. The QA Inspector also intermittently observed in process welding parameters and determined that the SAW parameters and minimum preheat/interpass temperature appeared to be in general compliance with the contract requirements.
