Contract #: 04-0120F4Cty: SF/ALA Rte: 80 PM: 13.2/13.9File #: 13.28**WELDING INSPECTION REPORT****Resident Engineer:** Pursell, Gary**Address:** 333 Burma Road**City:** Oakland, CA 94607**Report No:** WIR-006635**Date Inspected:** 06-May-2009**Project Name:** SAS Superstructure**OSM Arrival Time:** 700**Prime Contractor:** American Bridge/Fluor Enterprises, a JV**OSM Departure Time:** 1530**Contractor:** Oregon Iron Works Clackamas, Or.**Location:** Clackamas, OR**CWI Name:** Mike Gregson, Rob Walters**CWI Present:** Yes No**Inspected CWI report:** Yes No N/A**Rod Oven in Use:** Yes No N/A**Electrode to specification:** Yes No N/A**Weld Procedures Followed:** Yes No N/A**Qualified Welders:** Yes No N/A**Verified Joint Fit-up:** Yes No N/A**Approved Drawings:** Yes No N/A**Approved WPS:** Yes No N/A**Delayed / Cancelled:** Yes No N/A**Bridge No:** 34-0006**Component:** Hinge K Pipe Beams**Summary of Items Observed:**

WELDING INSPECTION REPORT

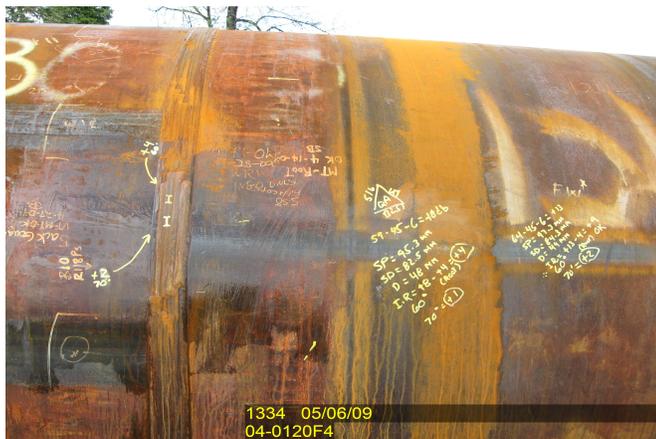
QA Inspector performed 100% ultrasonic weld inspection on the completed weld repair for fuse assembly 120A-2 (a124-3 Half Fuse to a124-11 Half Fuse), designated as weld joint #WM3-18 and 1 rejectable/1 recordable indication was found, on this date. QA Inspector marked out the location of the rejectable/recordable indications and wrote the applicable ultrasonic testing information next to the indications (location, depth, sound path, etc.). See applicable ultrasonic testing report (TL6027), for additional details.

present with QC Inspector Steve Barnett to also compare results, on the scheduled swing shift. QA Inspector Clete Henke called QA Inspector on this date, in the evening and confirmed that the indications were present and ultrasonic testing results were similar. See attached picture below.

QA Inspector notified QC Inspector Mike Gregson of the ultrasonic testing results and suggested that a qualified OIW QC Inspector should verify the results and compare to QA Inspector's results. Mr. Mike Gregson explained that swing shift QC Inspector Steve Barnett would perform the ultrasonic weld testing on the areas in the weld repair that QA Inspector previously marked up. QA Inspector noted QA Inspector Clete Henke would also be

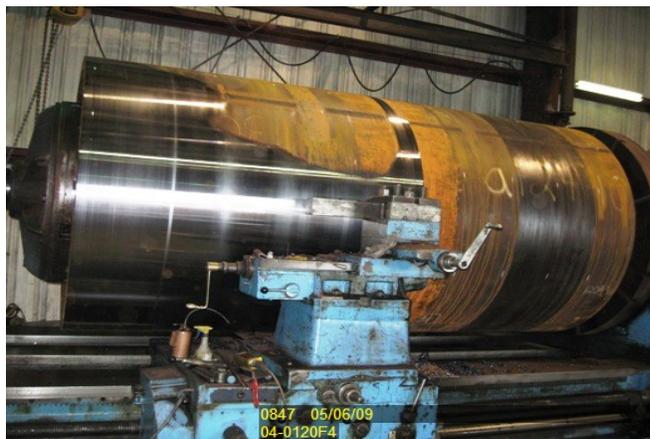
QA Inspector arrived at A&G Machining on this date to witness the in-process rough machining of fuse assembly 120A-3. QA Inspector noticed the first cut pass was started on 5/5/09, was approximately 50% complete on this date and A&G Machinist explained to QA Inspector that the depth was set at .160" (4.06mm) and would probably be complete by end of shift. A&G Machinist explained that the second cut pass would be started the following day on 5/7/09 and should be completed by 5/8/09. A&G explained that the third and possibly final pass, to achieve desired results of a final 1903mm diameter, should start on 5/8/09, with a possible completion date of 5/11/09. See attached machining pictures below.
