Quality Assurance and Source Inspection

Contract #: 04-0120F4Cty: SF/ALA Rte: 80 PM: 13.2/13.9File #: 13.28**WELDING INSPECTION REPORT****Resident Engineer:** Pursell, Gary**Address:** 333 Burma Road**City:** Oakland, CA 94607**Report No:** WIR-006748**Date Inspected:** 13-May-2009**Project Name:** SAS Superstructure**OSM Arrival Time:** 700**Prime Contractor:** American Bridge/Fluor Enterprises, a JV**OSM Departure Time:** 1530**Contractor:** Oregon Iron Works Clackamas, Or.**Location:** Clackamas, OR**CWI Name:** Mike Gregson, Rob Walters**CWI Present:** Yes No**Inspected CWI report:** Yes No N/A**Rod Oven in Use:** Yes No N/A**Electrode to specification:** Yes No N/A**Weld Procedures Followed:** Yes No N/A**Qualified Welders:** Yes No N/A**Verified Joint Fit-up:** Yes No N/A**Approved Drawings:** Yes No N/A**Approved WPS:** Yes No N/A**Delayed / Cancelled:** Yes No N/A**Bridge No:** 34-0006**Component:** Hinge K Pipe Beams**Summary of Items Observed:**

WELDING INSPECTION REPORT

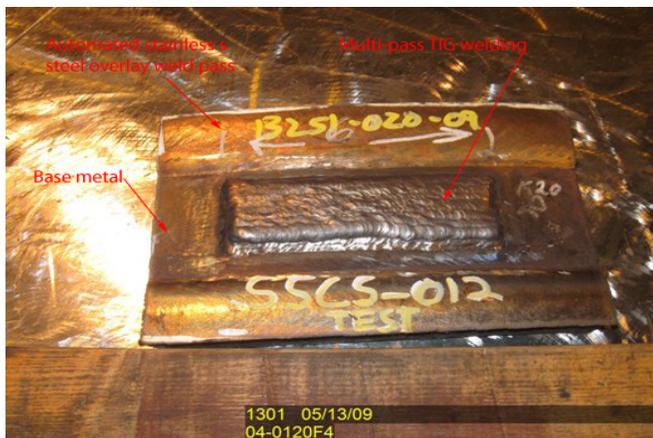
QA Inspector received verbal notification from OIW welding supervisor Vern Taute, that two more layer passes would be added to the existing layer passes on this previously run PQR #SSCS-12. QA Inspector arrived at the testing Bay 1 and met with QC Inspector Scott Reed. Mr. Scott Reed explained to QA Inspector that welder #K20, Mr. Randy Kleeman, would be performing tungsten inert gas (TIG) welding, using electrode designated as AWS A5.9 ER316L, in the flat position. Mr. Scott Reed explained that he would be present during the welding and to verify/document in-process welding parameters (amps/volts), pre-heat temperatures, distance travelled, etc. QA Inspector assigned the following lot #B251-020-09 and completed the applicable TL6032, at the completion of the PQR. See PQR #SSCS-12 photo below.

Note: QA Inspector received an inspection request on 5/7/09 from OIW QC manager Tom Tomovick, explaining that OIW would be running a PQR, for the potential weld repairs on the stainless steel overlay. QA Inspector arrived at OIW bay 3 to witness the PQR on 5/8/09 and met with QC Inspector Scott Reed. Mr. Scott Reed explained that welder #K20, Mr. Randy Kleeman, would be performing tungsten inert gas (TIG) welding, using electrode designated as AWS A5.9 ER309L and AWS A5.9 ER316L, in the flat position. Mr. Scott Reed explained that he would be present during the welding and to verify and document in-process welding parameters (amps/volts), pre-heat temperatures, distance travelled, etc. QA Inspector noticed that the PQR test plate had a square cut in the carbon steel base metal approximately 150mm long x 55mm wide x 6mm deep and Mr. Randy Kleeman was welding with the ER309L on all passes and the final two layer passes would be welded with the ER316L electrode. QA Inspector witnessed Mr. Scott Reed was present at all times during the welding process and Mr. Scott Reed was recording data on the applicable data sheet for procedure qualification. QA Inspector noted that Mr. Randy Kleeman would not be finished welding by end of shift and QA Inspector Clete Henke would be present for the completion of this PQR SACS-12. QA Inspector noted Mr. Randy Kleeman and Mr. Scott Reed appeared to be in compliance with AWS D1.6 and Mr. Scott Reed explained that a copy of the PQR data sheet would be provided to QA Inspector, after completion of the PQR.
