Contract #: 04-0120F4Cty: SF/ALA Rte: 80 PM: 13.2/13.9File #: 13.28**WELDING INSPECTION REPORT****Resident Engineer:** Pursell, Gary**Address:** 333 Burma Road**City:** Oakland, CA 94607**Report No:** WIR-006962**Date Inspected:** 28-May-2009**Project Name:** SAS Superstructure**OSM Arrival Time:** 1400**Prime Contractor:** American Bridge/Fluor Enterprises, a JV**OSM Departure Time:** 2230**Contractor:** Oregon Iron Works Clackamas, Or.**Location:** Clackamas, Oregon**CWI Name:** Steve Barnett**CWI Present:** Yes No**Inspected CWI report:** Yes No N/A**Rod Oven in Use:** Yes No N/A**Electrode to specification:** Yes No N/A**Weld Procedures Followed:** Yes No N/A**Qualified Welders:** Yes No N/A**Verified Joint Fit-up:** Yes No N/A**Approved Drawings:** Yes No N/A**Approved WPS:** Yes No N/A**Delayed / Cancelled:** Yes No N/A**Bridge No:** 34-0006**Component:** Hinge K Pipe Beams**Summary of Items Observed:**

WELDING INSPECTION REPORT

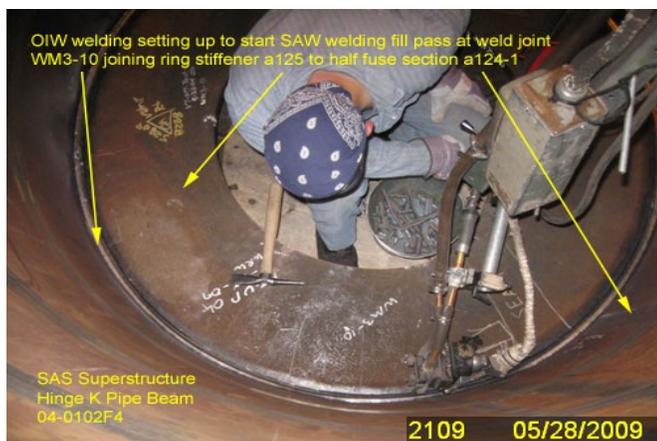
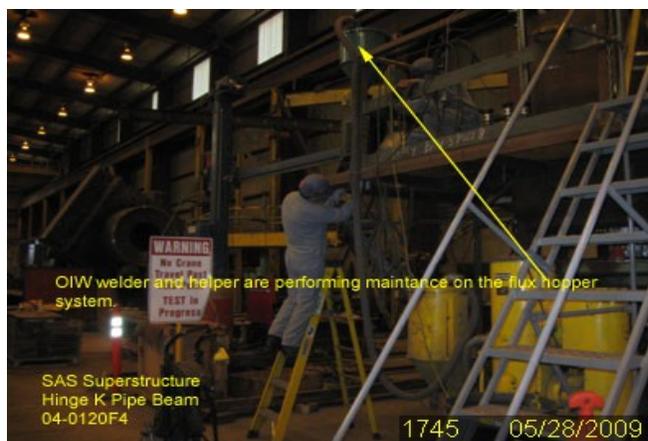
QA Inspector Brannon randomly observed OIW qualified welder Mr. Mikhail Bannikov ID#B28 and one helper welding root/fill pass's joining stiffener ring MK #a125 (HPS 485 W) to hinge K pipe beam half section MK#a124-5 (HPS 485 W). The partial joint penetration (PJP) groove weld is identified as weld joint #WM3-10. Mr. Bannikov was observed welding in the 1G (flat) position utilizing submerged arc welding (SAW) process with a 2.4mm diameter electrode, filler metal brand Lincoln Electric LA85 class F9A4-Eni5-G-H2. QA Inspector Brannon observed the OIW QC CWI Inspector Mr. Steve Barnett verifying that the pre-heat of 350°F and welding parameters were in accordance with the Welding Procedure Specification (WPS). Welding parameters measured by QA are as follows for root/fill: 370/586 amps, 27.6/35.2 volts and a travel speed of 306/457mm per minute respectively appear to be in conformance with approved welding procedure specification WPS 4020 revision number 1.

QA Inspector Brannon observed QC Inspector Mr. Steve Barnett perform visual inspection (VT) and magnetic particle testing (MT) cover pass's at hinge k pipe beam fuse section a124-9 (HPS 485 W) ring stiffener's MK#a125 and b125 weld joints WM3-02 ~ WM3-WM3-11 partial joint penetration (PJP) weld. QA Inspector Brannon also, performed visual inspection (VT) and magnetic particle testing (MT) cover pass's at hinge k pipe beam fuse section a124-9 (HPS 485 W) ring stiffener's MK#a125 and b125 weld joints WM3-02 ~

The following digital photograph below illustrates observation of the activities being performed.
