DEPARTMENT OF TRANSPORTATION

Quality Assurance and Source Inspection

Contract #: 04-0120F4Cty: SF/ALA Rte: 80 PM: 13.2/13.9File #: 13.28**WELDING INSPECTION REPORT****Resident Engineer:** Pursell, Gary**Address:** 333 Burma Road**City:** Oakland, CA 94607**Report No:** WIR-007014**Date Inspected:** 02-Jun-2009**Project Name:** SAS Superstructure**OSM Arrival Time:** 700**Prime Contractor:** American Bridge/Fluor Enterprises, a JV**OSM Departure Time:** 1530**Contractor:** Oregon Iron Works Clackamas, Or.**Location:** Clackamas, OR**CWI Name:** Mike Gregson, Rob Walters**CWI Present:** Yes No**Inspected CWI report:** Yes No N/A**Rod Oven in Use:** Yes No N/A**Electrode to specification:** Yes No N/A**Weld Procedures Followed:** Yes No N/A**Qualified Welders:** Yes No N/A**Verified Joint Fit-up:** Yes No N/A**Approved Drawings:** Yes No N/A**Approved WPS:** Yes No N/A**Delayed / Cancelled:** Yes No N/A**Bridge No:** 34-0006**Component:** Hinge K Pipe Beams**Summary of Items Observed:**

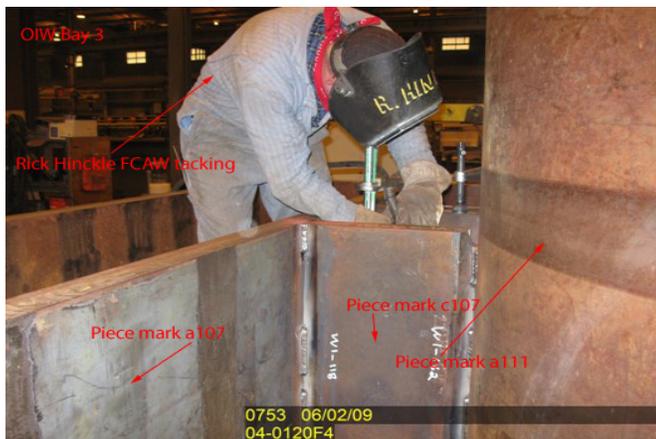
QA Inspector witnessed welder #H49, Mr. Rick Hinkle, FCAW tacking of various stiffener plates, to the base plate, piece mark identified as a110, for assembly 102A-4, in the flat (1F) position. QA Inspector noted Mr. Rick Hinkle was performing pre-heat, utilizing a single torch and recorded temperatures of approximately 400F (204C). QA Inspector noticed QC Inspector Rob Walters was present to monitor in-process welding parameters (amps/volts) and continuous pre-heat temperatures. QA Inspector noted Mr. Rick Hinkle appeared to be welding in accordance with the applicable approved welding procedure specification (WPS 3049). See picture below of Mr. Rick Hinkle FCAW tacking.

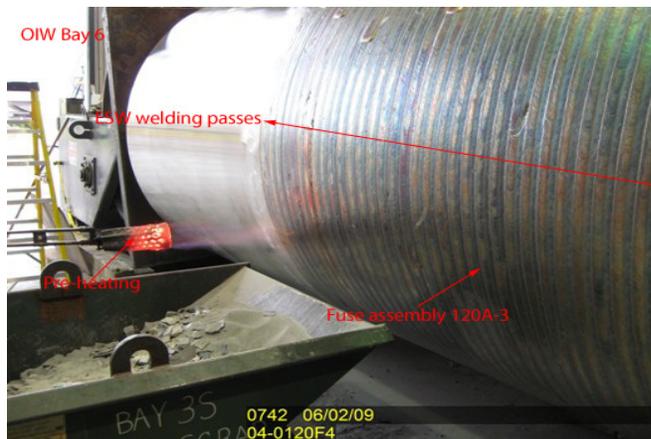
QA Inspector noticed that the stainless steel overlay welding was in-process, on this fuse assembly 120A-3. QA Inspector witnessed welder #J6, Mr. Craig Jacobson performing electro slag welding (ESW) in the flat position, utilizing Soudokay brand Soudotape 309L stainless steel consumable strip. QA Inspector noted the first ESW welding passes were approximately one-half complete and the remaining two layers would be welded utilizing Soudotape 316L consumable strip. QA Inspector noticed QC Inspector's Mike Gregson and Rob Walters were present, to verify in-process welding parameters (amps/volts) and monitor in-process continuous pre-heat temperatures. QA Inspector spoke with QC Inspector Rob Walters and Mr. Rob Walters explained that welding amps were recorded as 1300 amps/25.5 volts, with a pre-heat temperature of approximately 225 Fahrenheit. QA Inspector verified Mr. Craig Jacobson was currently qualified for this welding process/position and randomly recorded pre-heat temperatures of approximately 250 Fahrenheit. QA Inspector noted that Mr. Craig Jacobson appeared to be in compliance with the applicable approved welding procedure specification (WPS 7003). See picture below of fuse assemble 120A-3.
