DEPARTMENT OF TRANSPORTATION

Quality Assurance and Source Inspection

Contract #: 04-0120F4Cty: SF/ALA Rte: 80 PM: 13.2/13.9File #: 70.28**WELDING INSPECTION REPORT****Resident Engineer:** Pursell, Gary**Address:** 333 Burma Road**City:** Oakland, CA 94607**Report No:** WIR-007053**Date Inspected:** 03-Jun-2009**Project Name:** SAS Superstructure**OSM Arrival Time:** 1300**Prime Contractor:** American Bridge/Fluor Enterprises, a JV**OSM Departure Time:** 2130**Contractor:** Japan Steel Works**Location:** Muroran, Japan**CWI Name:** Makhmud Ashadi**CWI Present:** Yes No**Inspected CWI report:** Yes No N/A**Rod Oven in Use:** Yes No N/A**Electrode to specification:** Yes No N/A**Weld Procedures Followed:** Yes No N/A**Qualified Welders:** Yes No N/A**Verified Joint Fit-up:** Yes No N/A**Approved Drawings:** Yes No N/A**Approved WPS:** Yes No N/A**Delayed / Cancelled:** Yes No N/A**Bridge No:** 34-0006**Component:** Tower, Jacking and Deviation Saddles**Summary of Items Observed:**

WEST DEVIATION SADDLES

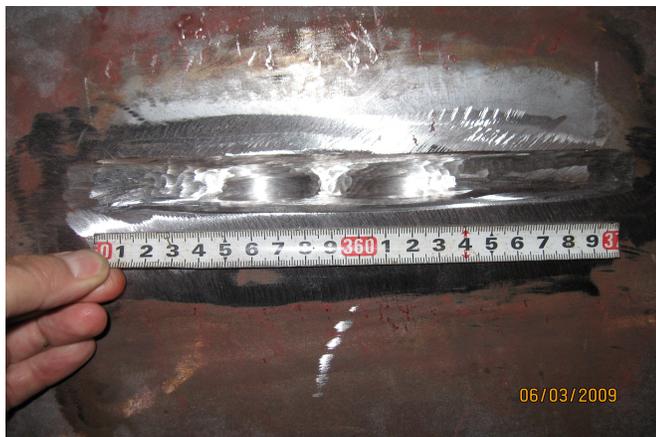
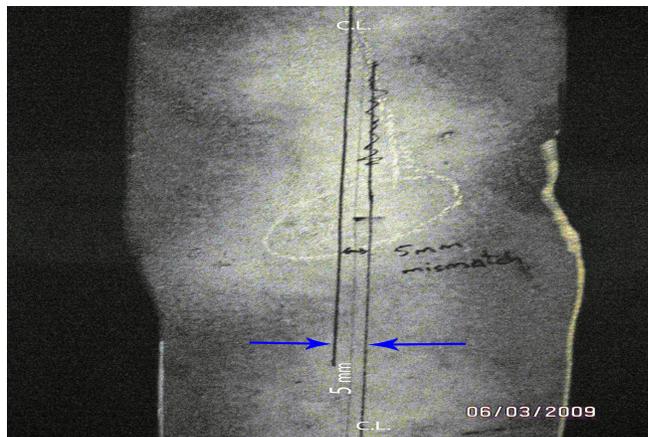
W2E2 - While resting idle in the Fabrication shop, QA Inspector noted a mismatch of cast rib to plate rib exceeding 3mm, (paragraph 3.3.3 of AWS D1.5 2002 and page 326, Shop Welding, paragraph G.2. of Special Provisions), QAI immediately informed QC CWI Mr. Chung Fu Kuan, who agreed there to be a mismatch that potentially exceeded AWS criteria. Further evaluation resulted in a rough dimension of 5mm. On site SMR Mr. Jay Dorst has been notified, awaiting disposition (see attached photos).
