**DEPARTMENT OF TRANSPORTATION**

Contract #: 04-0120F4Cty: SF/ALA Rte: 80 PM: 13.2/13.9File #: 13.28**WELDING INSPECTION REPORT****Resident Engineer:** Pursell, Gary**Address:** 333 Burma Road**City:** Oakland, CA 94607**Report No:** WIR-007093**Date Inspected:** 04-Jun-2009**Project Name:** SAS Superstructure**OSM Arrival Time:** 700**Prime Contractor:** American Bridge/Fluor Enterprises, a JV**OSM Departure Time:** 1530**Contractor:** Oregon Iron Works Clackamas, Or.**Location:** Clackamas, OR**CWI Name:** Mike Gregson, Rob Walters**CWI Present:** Yes No**Inspected CWI report:** Yes No N/A**Rod Oven in Use:** Yes No N/A**Electrode to specification:** Yes No N/A**Weld Procedures Followed:** Yes No N/A**Qualified Welders:** Yes No N/A**Verified Joint Fit-up:** Yes No N/A**Approved Drawings:** Yes No N/A**Approved WPS:** Yes No N/A**Delayed / Cancelled:** Yes No N/A**Bridge No:** 34-0006**Component:** Hinge K Pipe Beams**Summary of Items Observed:**

Hinge-K Pipe Beam Assembly 102A-1: 6/4/09

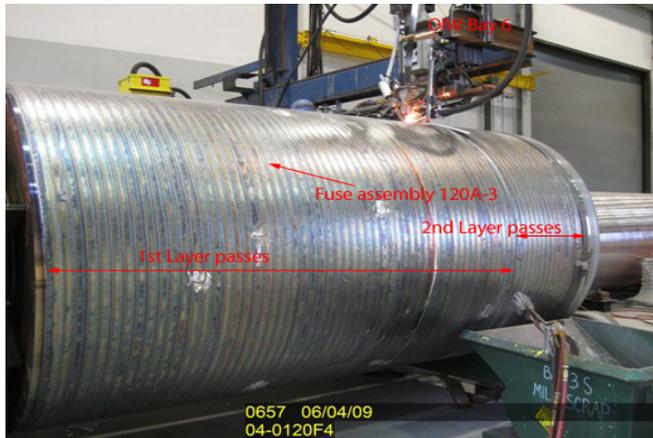
Hinge-K Pipe Beam Fuse Assembly 120A-3: 6/4/09

a124-12 Half Fuse to a124-10 Half Fuse

QA Inspector noticed that the stainless steel overlay welding was in-process, on this fuse assembly 120A-3. QA Inspector witnessed welder #J6, Mr. Craig Jacobson, performing electro slag welding (ESW) in the flat position, utilizing Soudokay brand Soudotape 316L stainless steel consumable strip. QA Inspector noted the first ESW welding passes were complete, utilizing Soudokay brand Soudotape 309L stainless steel consumable strip and the second layer passes were in-process, approximately 25% complete. QA Inspector noticed QC Inspector's Mike Gregson and Rob Walters were present, to verify in-process welding parameters (amps/volts) and monitor in-process continuous pre-heat temperatures. QA Inspector spoke with QC Inspector Rob Walters and Mr. Rob Walters explained that welding amps were recorded as 1260 amps/24.5 volts, with a pre-heat temperature of approximately 225 Fahrenheit. QA Inspector verified Mr. Craig Jacobson was currently qualified for this welding process/position and randomly recorded pre-heat temperatures of approximately 250 Fahrenheit. QA Inspector noted that Mr. Craig Jacobson appeared to be in compliance with the applicable approved welding procedure specification (WPS 7003). See picture below of fuse assemble 120A-3. See assembly 120A-3 picture below.

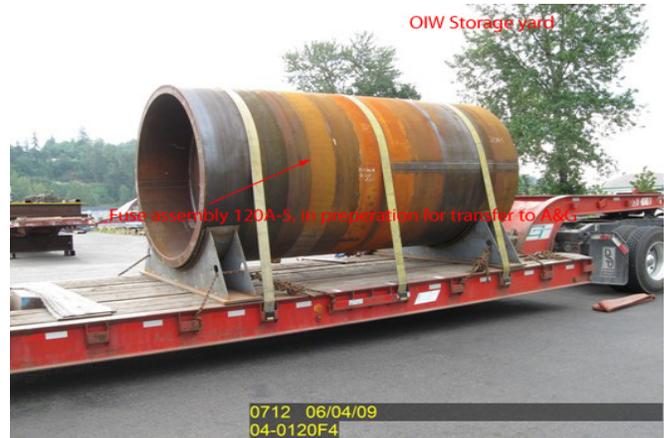
Hinge-K Pipe Beam Fuse Assembly 120A-5: 6/4/09

a124-14 Half Fuse to a124-2 Half Fuse

QA Inspector noticed this fuse assembly 120A-5 was being loaded on a trailer in preparation for the transfer to A&G Machining, for the rough machining process. See attached picture below.

Lead QA Inspector Joe Adame arrived at A&G Machining, on this date and noticed the fuse assembly 120A-4 was being loaded on a trailer, in preparation for transfer back to OIW fabrication shop. Mr. Adame witnessed the arrival of fuse assembly 120A-5 at A&G and the placement on the horizontal lathe, in preparation for rough machining. A&G explained that the following final outside diameter measurements were recorded by A&G machinist, on the completed fuse assembly 120A-4: 1902.76mm, 1902.59mm, 1902.53mm, 1902.66mm, 1902.97mm, 1902.76mm, 1902.66mm and 1902.89mm. OIW machinist was present at A&G on 6/1/09, to verify these dimensional measurement and release the assembly 120A-4.
