**DEPARTMENT OF TRANSPORTATION**

Contract #: 04-0120F4Cty: SF/ALA Rte: 80 PM: 13.2/13.9File #: 69.28**WELDING INSPECTION REPORT****Resident Engineer:** Pursell, Gary**Address:** 333 Burma Road**City:** Oakland, CA 94607**Report No:** WIR-007235**Date Inspected:** 26-May-2009**Project Name:** SAS Superstructure**OSM Arrival Time:** 1900**Prime Contractor:** American Bridge/Fluor Enterprises, a JV**OSM Departure Time:** 700**Contractor:** Zhenhua Port Machinery Company, Ltd (ZPMC), Changxing Island **Location:** Shanghai, China**CWI Name:** See Below**CWI Present:** Yes No**Inspected CWI report:** Yes No N/A**Rod Oven in Use:** Yes No N/A**Electrode to specification:** Yes No N/A**Weld Procedures Followed:** Yes No N/A**Qualified Welders:** Yes No N/A**Verified Joint Fit-up:** Yes No N/A**Approved Drawings:** Yes No N/A**Approved WPS:** Yes No N/A**Delayed / Cancelled:** Yes No N/A**Bridge No:** 34-0006**Component:** OBG Fabrication**Summary of Items Observed:**

## WELDING INSPECTION REPORT

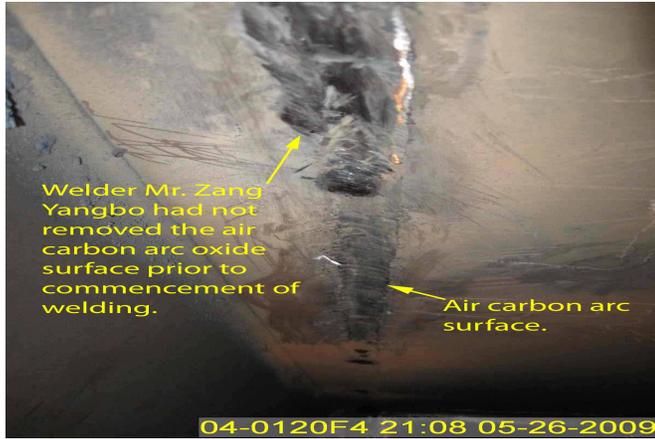
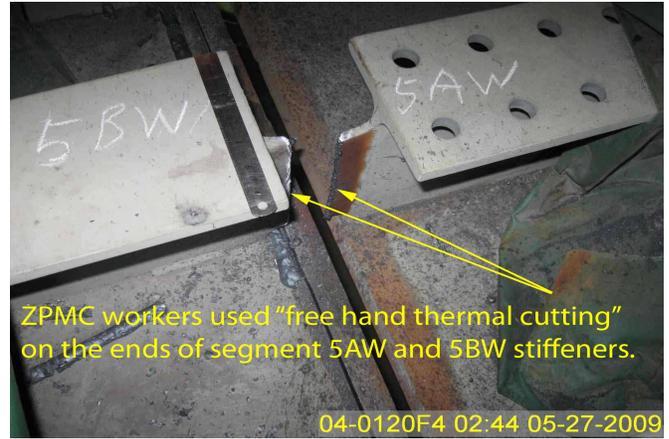
The QA Inspector observed ZPMC personnel are performing 'free hand thermal cutting' on OBG segment 5AW and 5BW stiffeners without use of a mechanical guide. Access to the areas being cut does not appear to be restricted due to cross sectional geometry and or position in so far as mechanical guides could not be used. AWS D1.5 2002 section 3.2.3 states "Steel and weld metal may be thermally cut, provided a smooth and regular surface free from cracks and notches is secured, and provided that an accurate profile is secured by the use of a mechanical guide. Freehand thermal cutting shall be done only where approved by the Engineer." This QA Inspector issued an Incident Report to document this Code violation. See photos for additional information.
